YOUR ONESURVEY
HOME REPORT

16 Lilybank Mews
Dundee
DD4 6EQ

SINGLE SURVEY

Single Survey

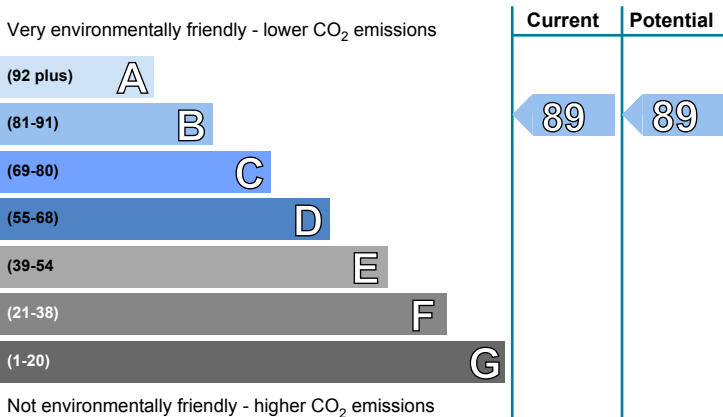
Environmental Impact (CO₂) Rating

This graph shows the effect of your home on the environment in terms of carbon dioxide (CO₂) emissions. The higher the rating, the less impact it has on the environment.
