Home Report

Single Survey

Property address	61a Brechin Road Kirriemuir DD8 4DE
Customer	Mrs Karen Tocher
Customer address	61a Brechin Road Kirriemuir DD8 4DE
Prepared by	Shepherd Chartered Surveyors
Date of inspection	03/10/2024

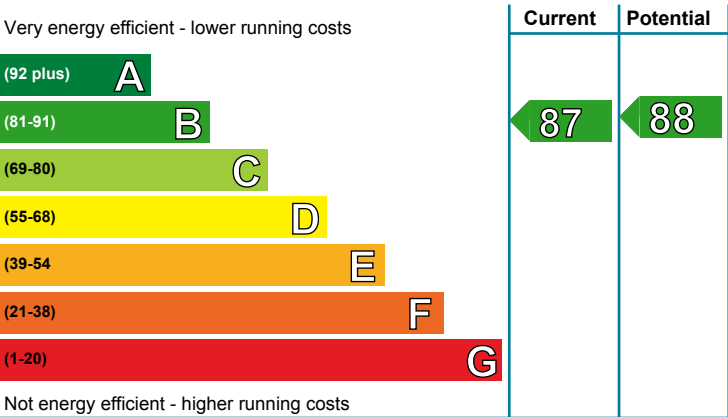
Energy Efficiency Rating

This graph shows the current efficiency of your home, taking into account both energy efficiency and fuel costs. The higher this rating, the lower your fuel bills are likely to be.

Your current rating is **band B (87)**. The average rating for EPCs in Scotland is **band D (61)**.

The potential rating shows the effect of undertaking all of the improvement measures listed within your recommendations report.

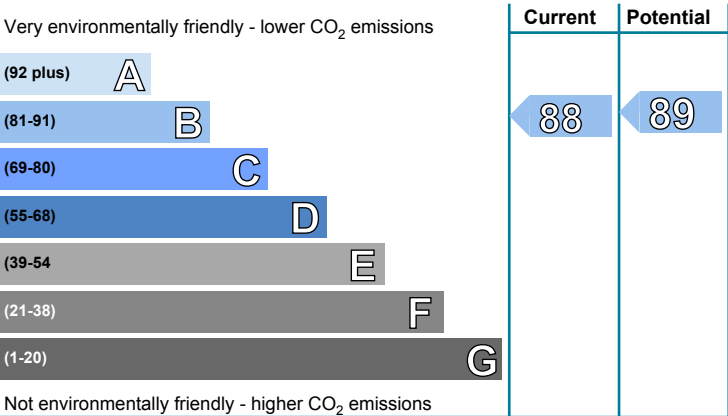
Environmental Impact (CO₂) Rating

This graph shows the effect of your home on the environment in terms of carbon dioxide (CO₂) emissions. The higher the rating, the less impact it has on the environment.
