YOUR ONESURVEY
HOME REPORT

192 Yarrow Terrace
Dundee
DD2 4HH

Single Survey

Surveyor Reference	EA2834
Customer	Ms. Laura Milroy
Selling address	192 Yarrow Terrace Dundee DD2 4HH
Date of Inspection	15/01/2025
Prepared by	Blair Ferguson, MRICS Dundee - Allied Surveyors Scotland Ltd

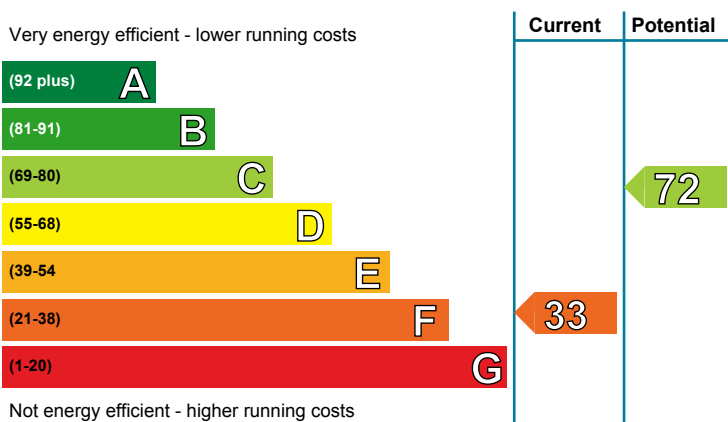
Energy Efficiency Rating

This graph shows the current efficiency of your home, taking into account both energy efficiency and fuel costs. The higher this rating, the lower your fuel bills are likely to be.

Your current rating is **band F (33)**. The average rating for EPCs in Scotland is **band D (61)**.

The potential rating shows the effect of undertaking all of the improvement measures listed within your recommendations report.
