# YOUR ONESURVEY HOME REPORT

1/R  
27 Park Avenue  
Dundee  
DD4 6NB

# SINGLE SURVEY

A report on the condition of the property, with categories being rated from 1 to 3.

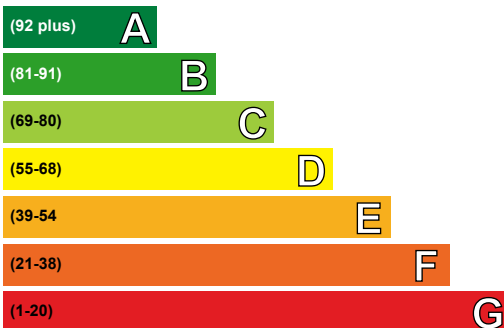
\* based upon the cost of energy for heating, hot water, lighting and ventilation, calculated using standard assumptions

Very energy efficient - lower running costs

Not energy efficient - higher running costs
