Home Report

Flat 38,
Homeglen House,
39 Maryville Avenue,
Giffnock,
Glasgow,
G46 7NF

Single Survey

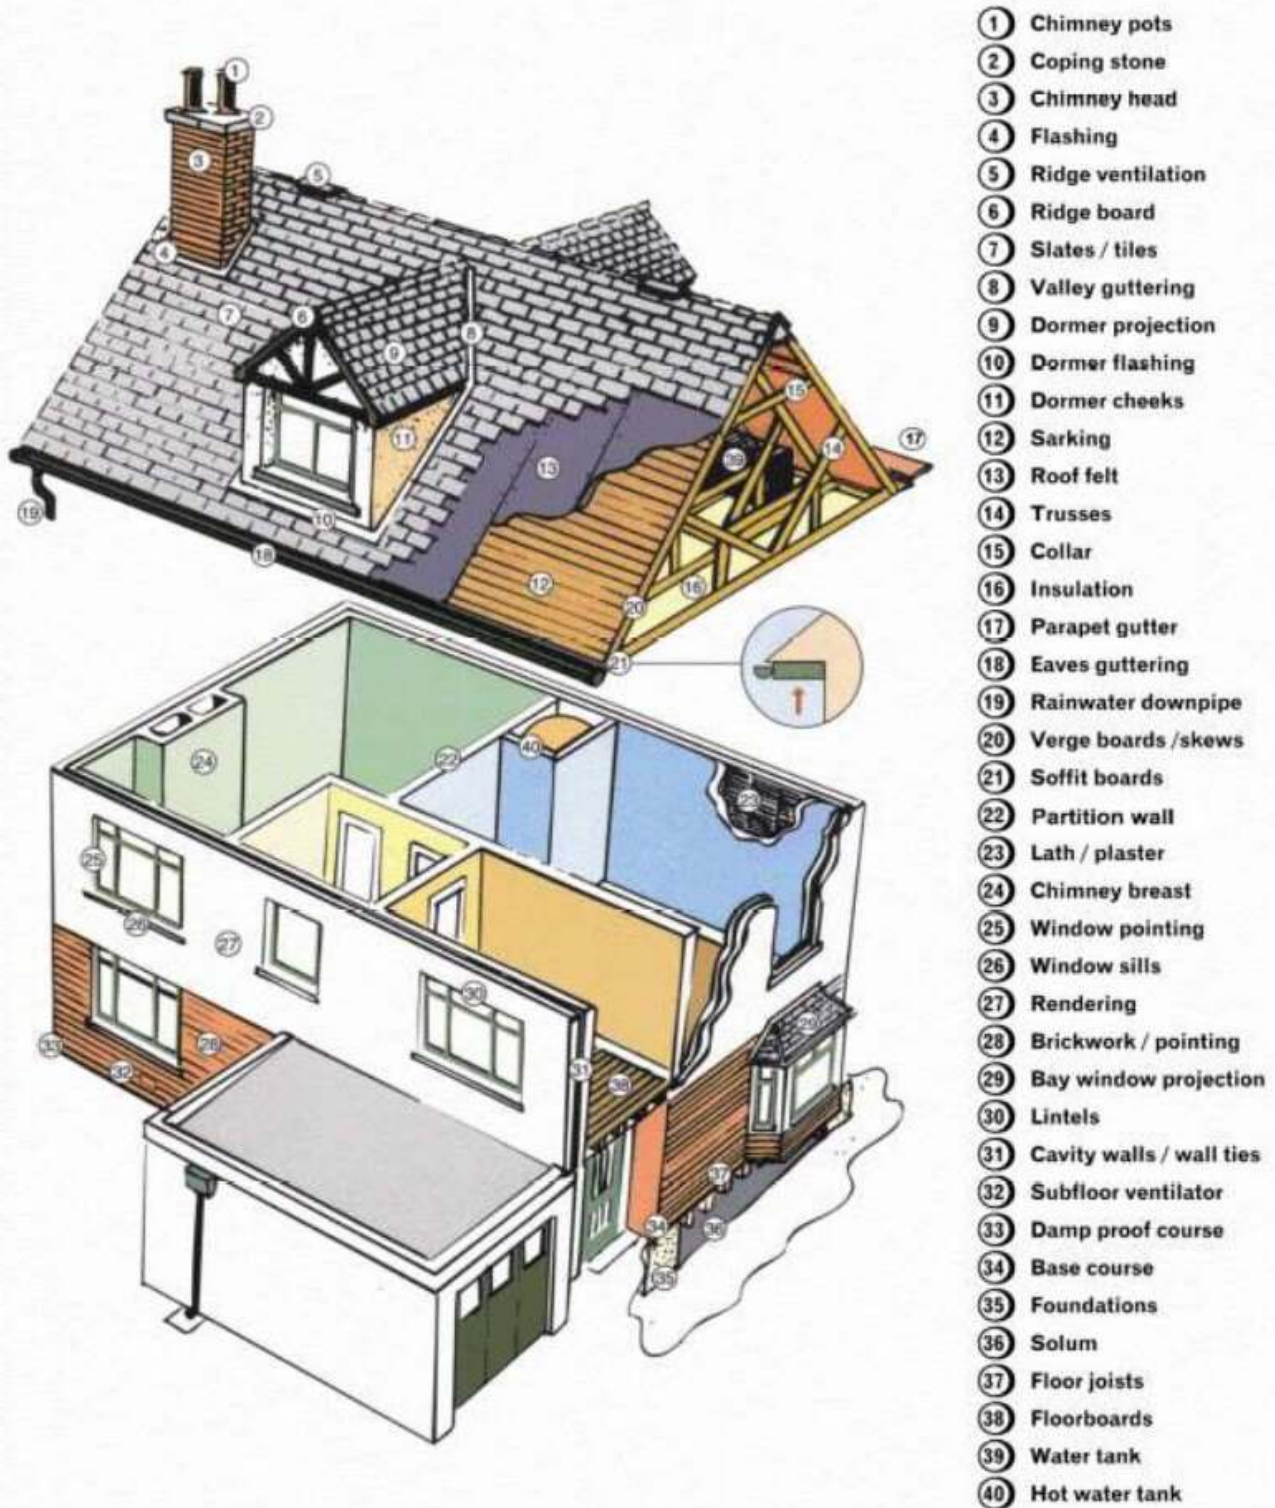
Sectional Diagram showing elements of a typical house

Reference may be made in this report to some or all of the above component parts of the property. This diagram may assist you in locating and understanding these items.
