YOUR ONESURVEY
HOME REPORT

4 Flat 8/1
Dublin Street
Edinburgh
EH1 3PP

HOME REPORT

SINGLE SURVEY

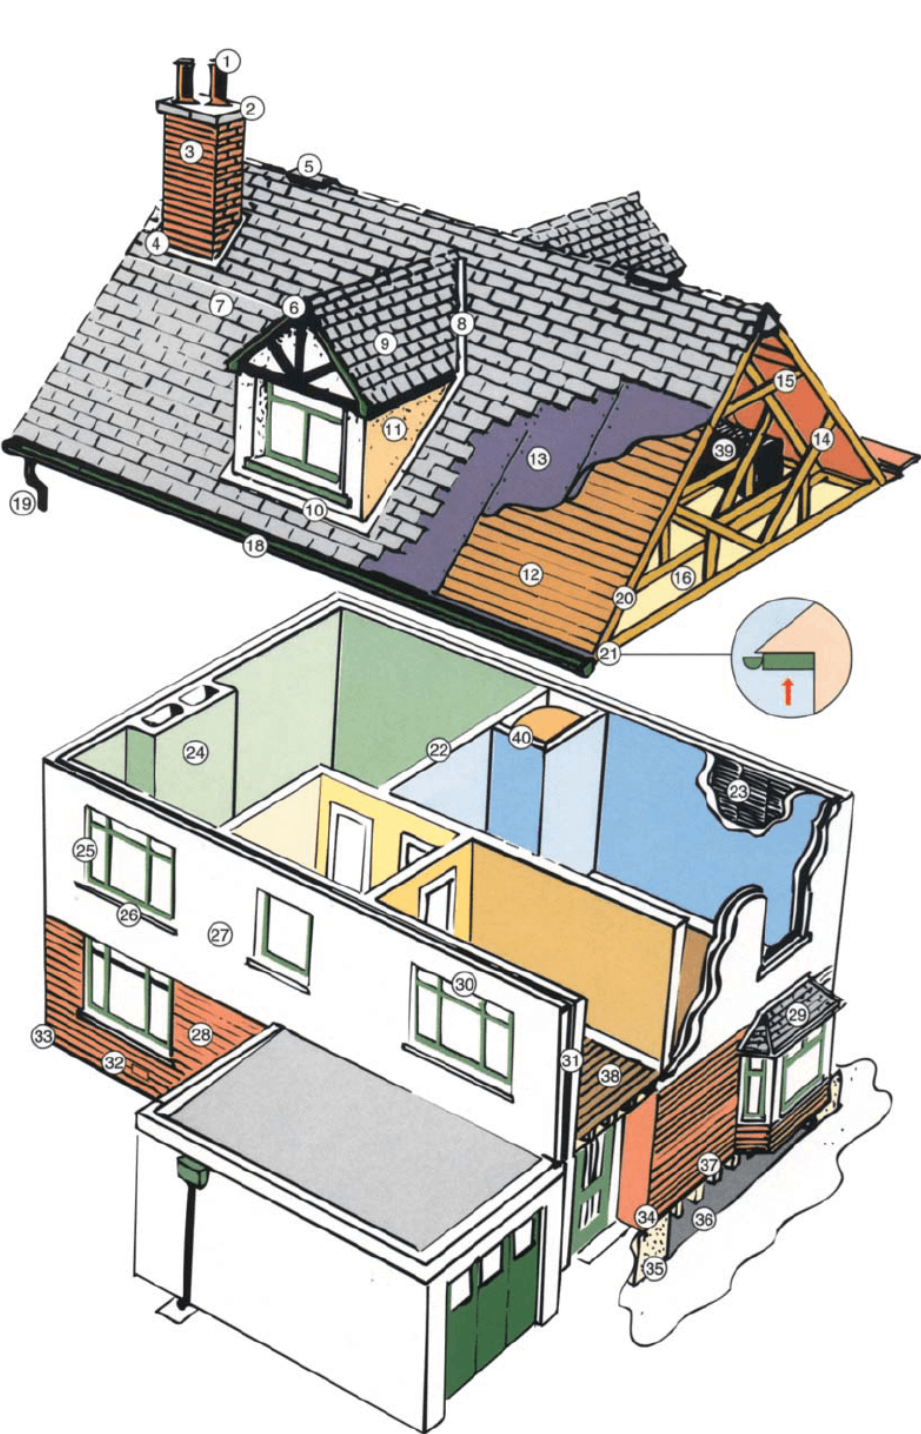
Sectional Diagram showing elements of a typical house

- ① Chimney pots
- ② Coping stone
- ③ Chimney head
- ④ Flashing
- ⑤ Ridge ventilation
- ⑥ Ridge board
- ⑦ Slates / tiles
- ⑧ Valley guttering
- ⑨ Dormer projection
- ⑩ Dormer flashing
- ⑪ Dormer cheeks
- ⑫ Sarking
- ⑬ Roof felt
- ⑭ Trusses
- ⑮ Collar
- ⑯ Insulation
- ⑰ Parapet gutter
- ⑱ Eaves guttering
- ⑲ Rainwater downpipe
- ⑳ Verge boards /skews
- ㉑ Soffit boards
- ㉒ Partiton wall
- ㉓ Lath / plaster
- ㉔ Chimney breast
- ㉕ Window pointing
- ㉖ Window sills
- ㉗ Rendering
- ㉘ Brickwork / pointing
- ㉙ Bay window projection
- ㉚ Lintels
- ㉛ Cavity walls / wall ties
- ㉜ Subfloor ventilator
- ㉝ Damp proof course
- ㉞ Base course
- ㉟ Foundations
- ㊱ Solum
- ㊲ Floor joists
- ㊳ Floorboards
- ㊴ Water tank
- ㊵ Hot water tank

Reference may be made in this report to some or all of the above component parts of the property. This diagram may assist you in locating and understanding these items.
