## **SINGLE SURVEY REPORT**

**14 MARDALE CRESCENT  
EDINBURGH  
EH10 5AG**

**13<sup>TH</sup> MAY 2024**

**PHILIP LOVEGROVE BSc PG DIP MSc (DIST) MRICS**

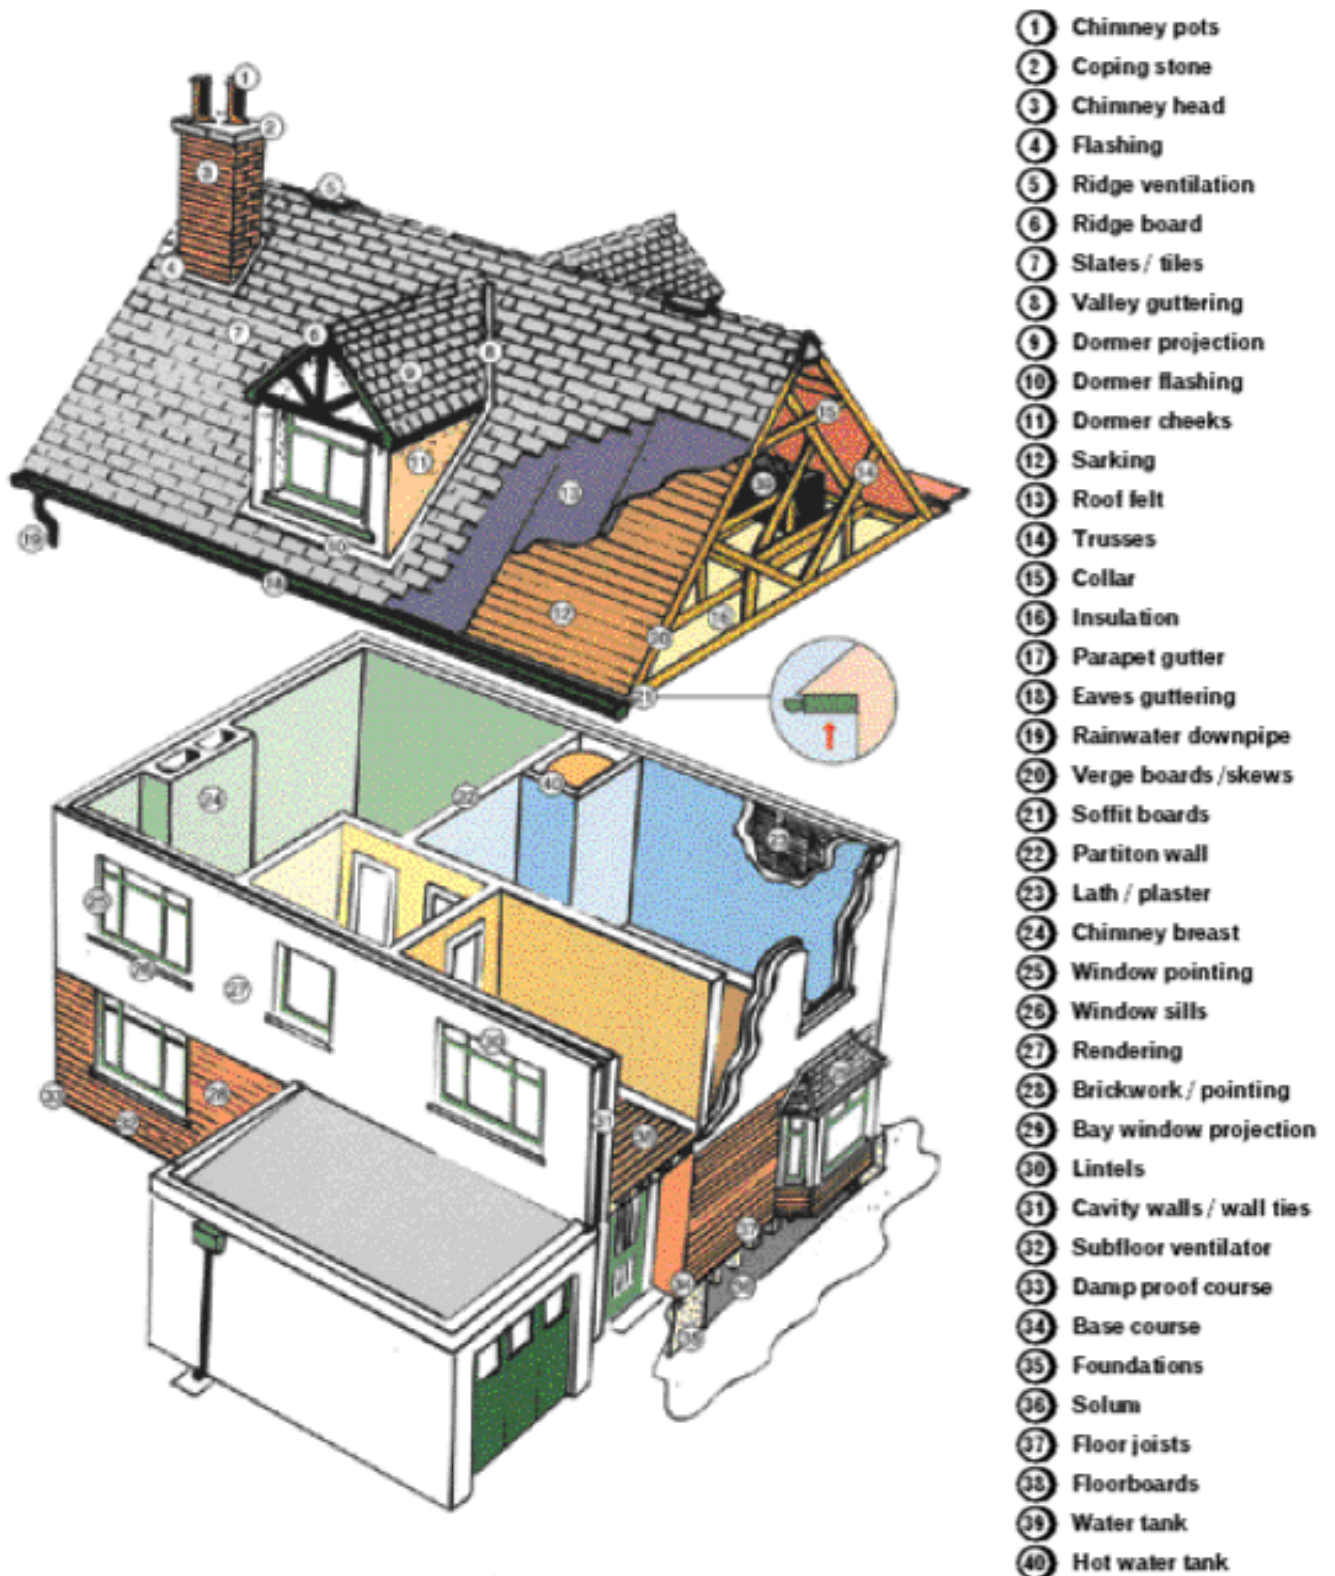
Sectional diagram showing elements of a typical house

- ① Chimney pots
- ② Coping stone
- ③ Chimney head
- ④ Flashing
- ⑤ Ridge ventilation
- ⑥ Ridge board
- ⑦ Slates / tiles
- ⑧ Valley guttering
- ⑨ Dormer projection
- ⑩ Dormer flashing
- ⑪ Dormer cheeks
- ⑫ Sarking
- ⑬ Roof felt
- ⑭ Trusses
- ⑮ Collar
- ⑯ Insulation
- ⑰ Parapet gutter
- ⑱ Eaves guttering
- ⑲ Rainwater downpipe
- ⑳ Verge boards /skews
- ㉑ Soffit boards
- ㉒ Partiton wall
- ㉓ Lath / plaster
- ㉔ Chimney breast
- ㉕ Window pointing
- ㉖ Window sills
- ㉗ Rendering
- ㉘ Brickwork / pointing
- ㉙ Bay window projection
- ㉚ Lintels
- ㉛ Cavity walls / wall ties
- ㉜ Subfloor ventilator
- ㉝ Damp proof course
- ㉞ Base course
- ㉟ Foundations
- ㊱ Solum
- ㊲ Floor joists
- ㊳ Floorboards
- ㊴ Water tank
- ㊵ Hot water tank

Reference may be made in this report to some or all of the above component parts of the property. This diagram may assist you in locating and understanding these terms.

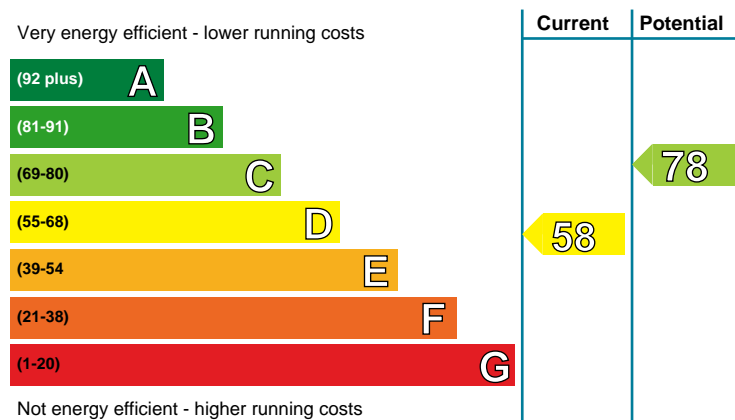
## Energy Efficiency Rating

This graph shows the current efficiency of your home, taking into account both energy efficiency and fuel costs. The higher this rating, the lower your fuel bills are likely to be.

Your current rating is **band D (58)**. The average rating for EPCs in Scotland is **band D (61)**.

The potential rating shows the effect of undertaking all of the improvement measures listed within your recommendations report.
