SINGLE SURVEY REPORT

2/6 CRAUFURDLAND EDINBURGH EH4 6DL

PHILIP LOVEGROVE BSc PG DIP MSc (DIST) MRICS

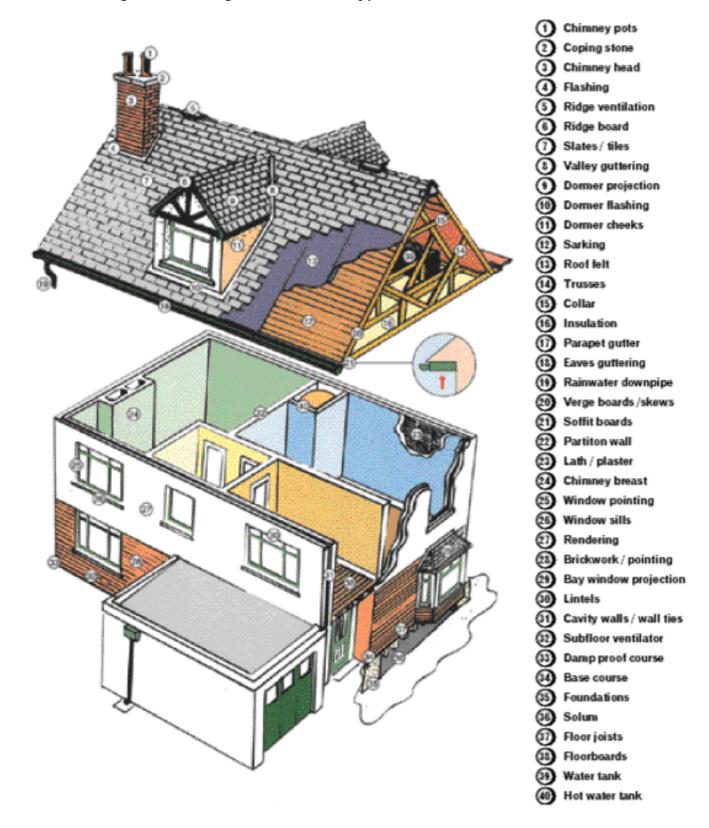
Sectional diagram showing elements of a typical house

Reference may be made in this report to some or all of the above component parts of the property. This diagram may assist you in locating and understanding these terms.
