# YOUR ONESURVEY HOME REPORT

13 House O'Hill Crescent  
Edinburgh  
EH4 5DE

# SINGLE SURVEY

# Single Survey

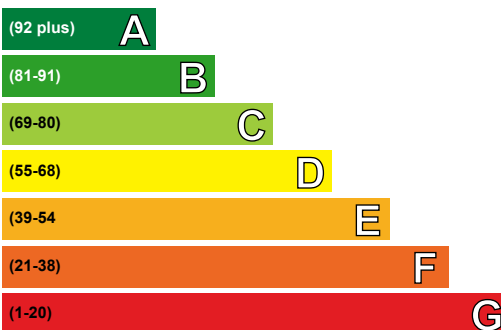
Very energy efficient - lower running costs

Not energy efficient - higher running costs

Current	Potential
69	82

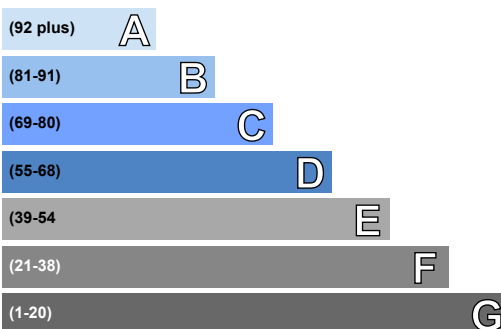
Very environmentally friendly - lower CO<sub>2</sub> emissions

Not environmentally friendly - higher CO<sub>2</sub> emissions

Current	Potential
63	78
