# YOUR ONESURVEY HOME REPORT

39/6 Bryson Road  
Edinburgh  
EH11 1DY

# SINGLE SURVEY

A report on the condition of the property, with categories  
being rated from 1 to 3.

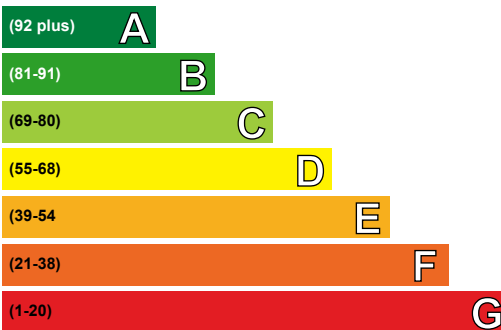
\* based upon the cost of energy for heating, hot water, lighting and ventilation, calculated using standard assumptions

Very energy efficient - lower running costs

Not energy efficient - higher running costs

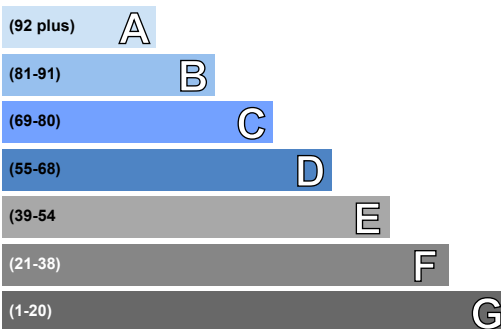
The potential rating shows the effect of undertaking all of the improvement measures listed within your recommendations report.

Very environmentally friendly - lower CO<sub>2</sub> emissions

Not environmentally friendly - higher CO<sub>2</sub> emissions
