# **HOME REPORT**

#### **CLUDEN WHITE HOUSE ROAD**

STRANRAER DG9 0JB

# SINGLE SURVEY

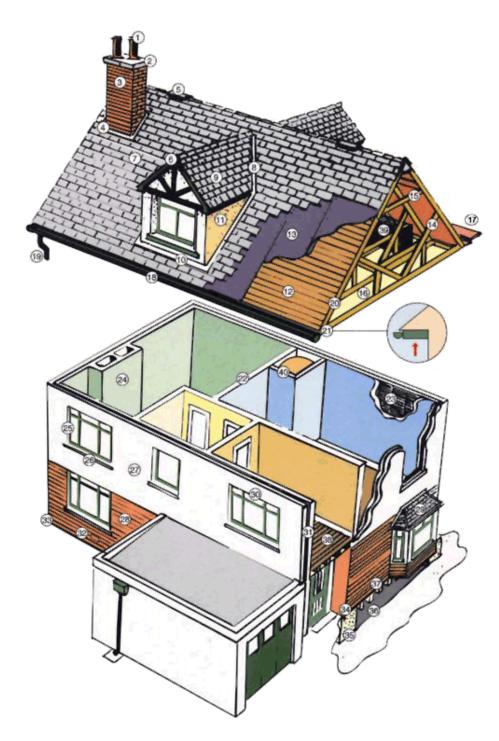
#### Sectional Diagram showing elements of a typical house

Reference may be made in this report to some or all of the above component parts of the property. This diagram may assist you in locating and understanding these items.

- 1) Chimney pots
- 2 Coping stone
- 3) Chimney head
- 4 Flashing
- 5 Ridge ventilation
- 6 Ridge board
- 7) Slates / tiles
- 8 Valley guttering
- 9 Dormer projection
- 10) Dormer flashing
- 11) Dormer cheeks
- 12) Sarking
- (13) Roof felt
- (14) Trusses
- (15) Collar
- 16 Insulation
- (17) Parapet gutter
- 18) Eaves guttering
- Rainwater downpipe
- 20) Verge boards/skews
- 21) Soffit boards
- 22) Partition wall
- 23) Lath / plaster
- 24) Chimney breast
- (25) Window pointing
- Window sills
- 27) Rendering
- (28) Brickwork / pointing
- 29) Bay window projection
- 30 Lintels
- (31) Cavity walls / wall ties
- 32) Subfloor ventilator
- 33) Damp proof course
- 34) Base course
- 35) Foundations
- 36) Solum
- 37) Floor joists
- 38) Floorboards
- 39) Water tank
- 40 Hot water tank
