YOUR ONESURVEY
HOME REPORT

12 Union Street
Montrose
DD10 8PY

Single Survey

Surveyor Reference	EA1775
Customer	Mr. Jamie McLaren
Selling address	12 Union Street Montrose DD10 8PY
Date of Re-inspection	27/06/2024
Date of Original Inspection	05/05/2023
Prepared by	Gary Black, MRICS Dundee - Allied Surveyors Scotland Ltd

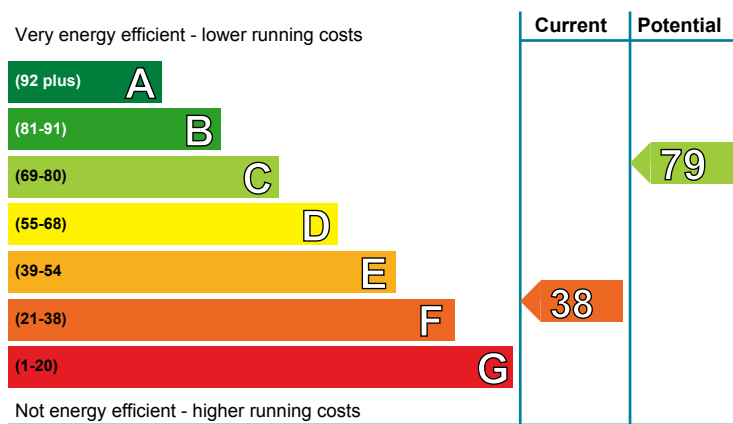
Energy Efficiency Rating

This graph shows the current efficiency of your home, taking into account both energy efficiency and fuel costs. The higher this rating, the lower your fuel bills are likely to be.

Your current rating is **band F (38)**. The average rating for EPCs in Scotland is **band D (61)**.

The potential rating shows the effect of undertaking all of the improvement measures listed within your recommendations report.

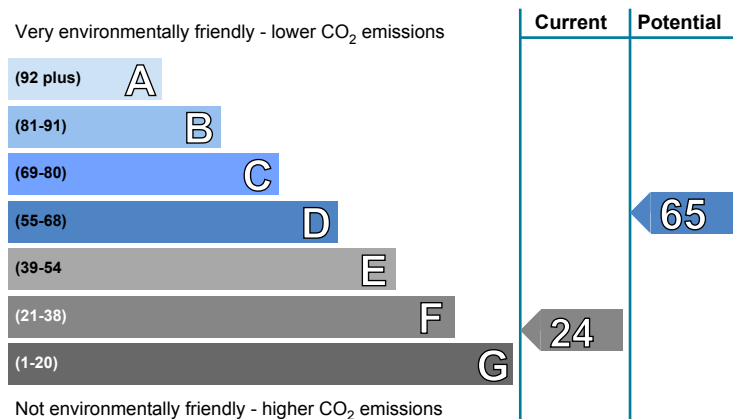
Environmental Impact (CO₂) Rating

This graph shows the effect of your home on the environment in terms of carbon dioxide (CO₂) emissions. The higher the rating, the less impact it has on the environment.
