YOUR ONESURVEY  
**HOME REPORT**

59 Railton Gardens  
Arbroath  
DD11 3FA

# Single Survey

# MORTGAGE VALUATION **REPORT**

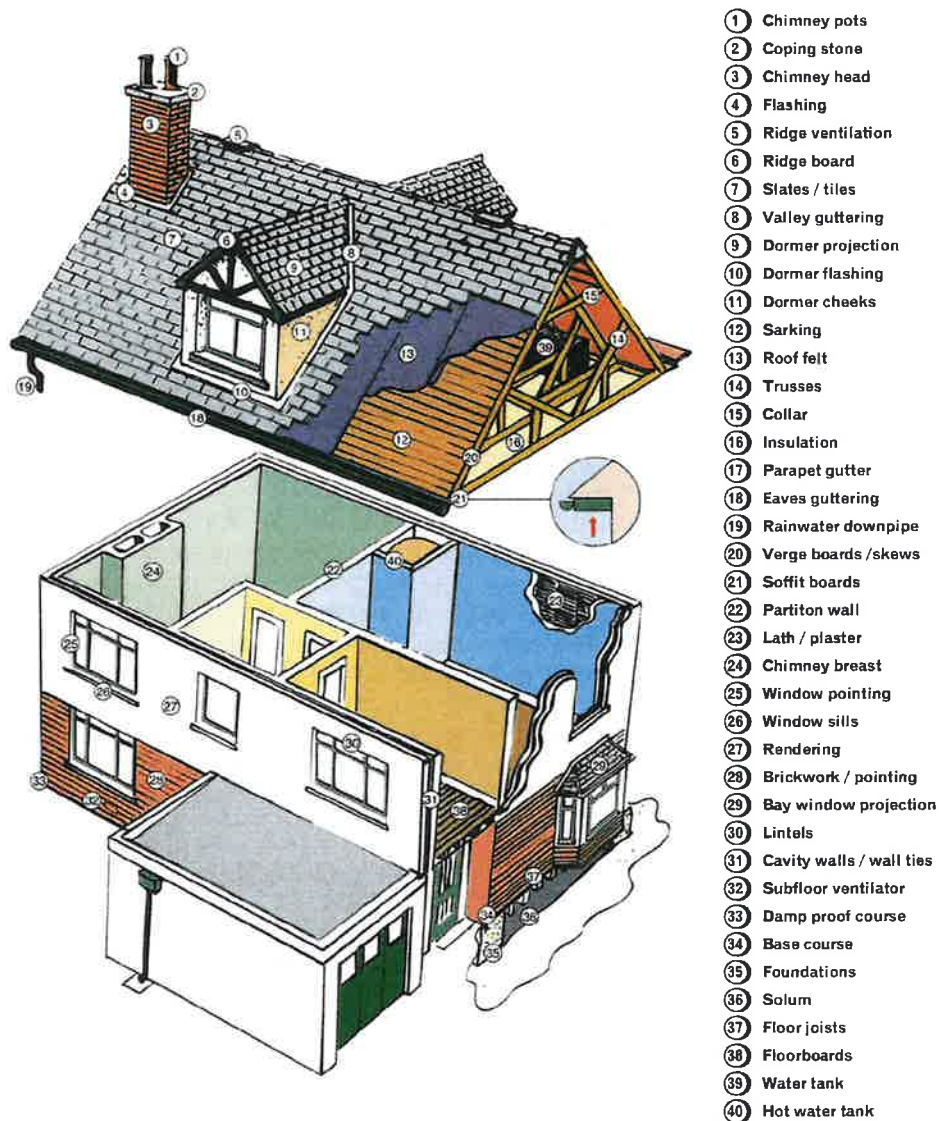
## Sectional Diagram showing elements of a typical house

Reference may be made in this report to some or all of the above component parts of the property. This diagram may assist you in locating and understanding these items.

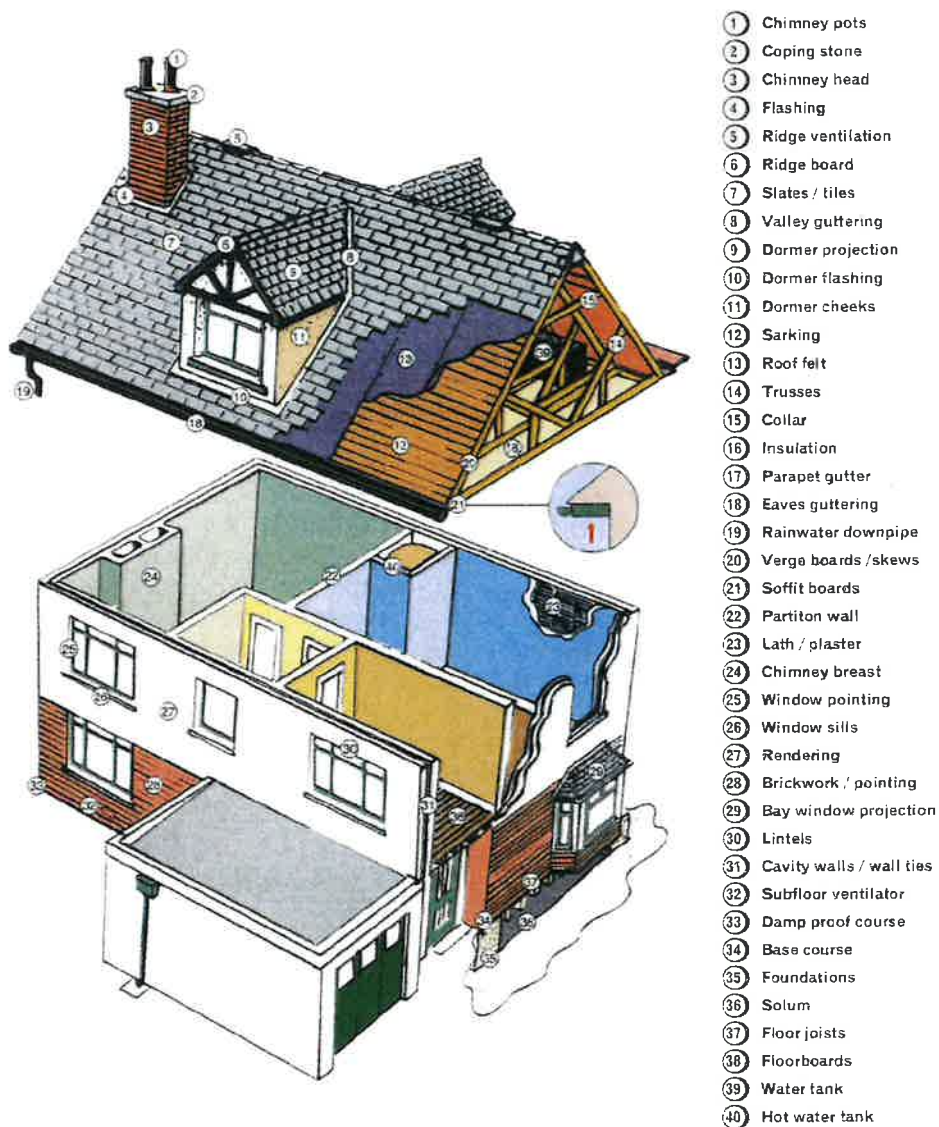
## Sectional Diagram showing elements of a typical house

Reference may be made in this report to some or all of the above component parts of the property. This diagram may assist you in locating and understanding these items.

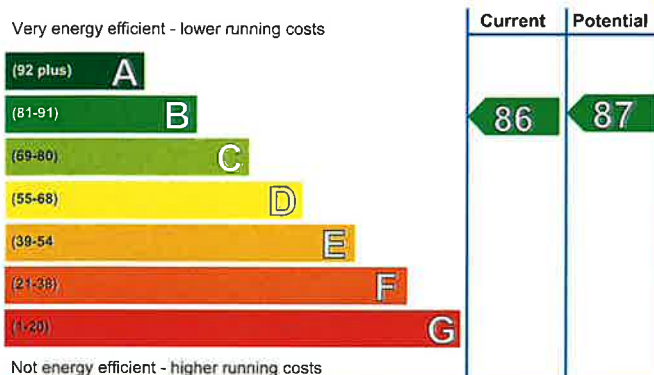
## Energy Efficiency Rating

Very energy efficient - lower running costs

Not energy efficient - higher running costs

The potential rating shows the effect of undertaking all of the improvement measures listed within your recommendations report.

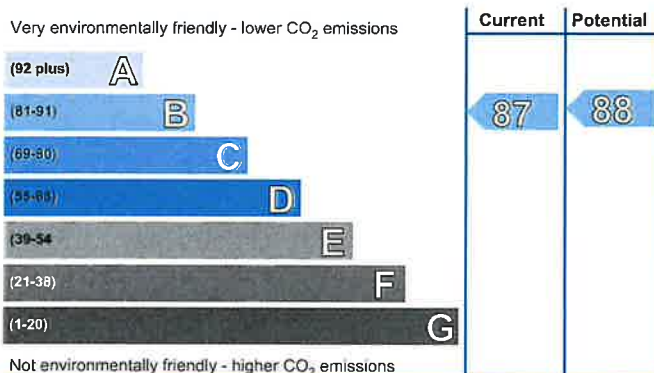
## Environmental Impact (CO<sub>2</sub>) Rating

Very environmentally friendly - lower CO<sub>2</sub> emissions

Not environmentally friendly - higher CO<sub>2</sub> emissions

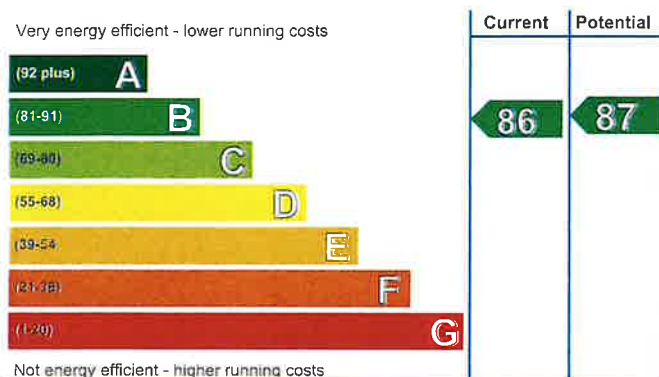
## Energy Efficiency Rating

This graph shows the current efficiency of your home, taking into account both energy efficiency and fuel costs. The higher this rating, the lower your fuel bills are likely to be.

Your current rating is **band B (86)**. The average rating for EPCs in Scotland is **band D (61)**.

The potential rating shows the effect of undertaking all of the improvement measures listed within your recommendations report.

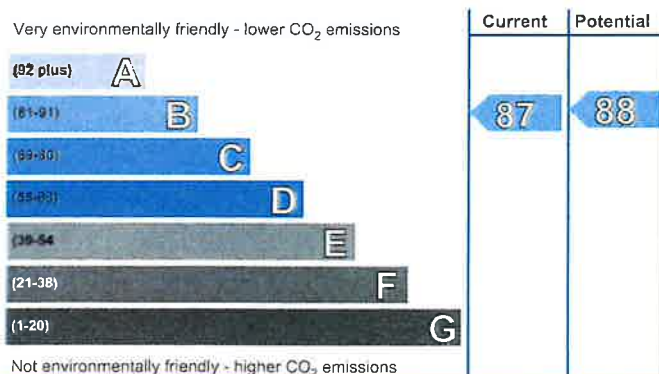
## Environmental Impact (CO<sub>2</sub>) Rating

This graph shows the effect of your home on the environment in terms of carbon dioxide (CO<sub>2</sub>) emissions. The higher the rating, the less impact it has on the environment.
