Home Report

Scottish Single Survey

Single Survey

Property address	45 Haining Wynd Muirhead Glasgow G69 9FH
Customer	Steven Kerr & Kelly Quail
Customer address	45 Haining Wynd Muirhead Glasgow G69 9FH
Prepared by	Shepherd Chartered Surveyors
Date of inspection	02/09/2024

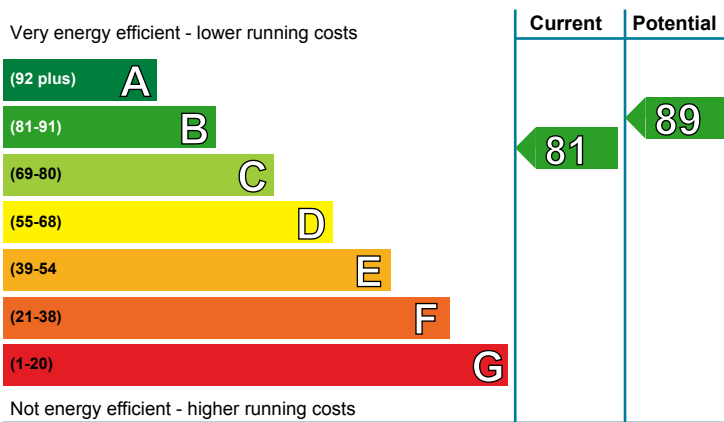
Energy Efficiency Rating

This graph shows the current efficiency of your home, taking into account both energy efficiency and fuel costs. The higher this rating, the lower your fuel bills are likely to be.

Your current rating is **band B (81)**. The average rating for EPCs in Scotland is **band D (61)**.

The potential rating shows the effect of undertaking all of the improvement measures listed within your recommendations report.

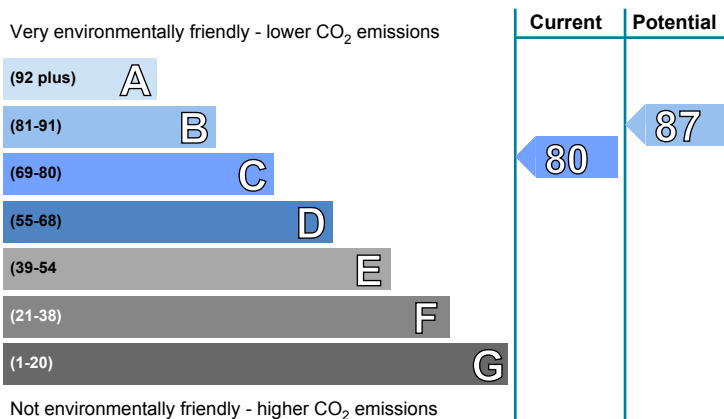
Environmental Impact (CO₂) Rating

This graph shows the effect of your home on the environment in terms of carbon dioxide (CO₂) emissions. The higher the rating, the less impact it has on the environment.
