Home Report

Scottish
Single Survey

Property address	44 Lloyd Court Rutherglen Glasgow G73 1NS
Customer	Jamie McGrory
Customer address	44 Lloyd Court Rutherglen Glasgow G73 1NS
Prepared by	Chaphard Chartarad Curvayara
Trepared by	Shepherd Chartered Surveyors
Date of inspection	04/09/2024

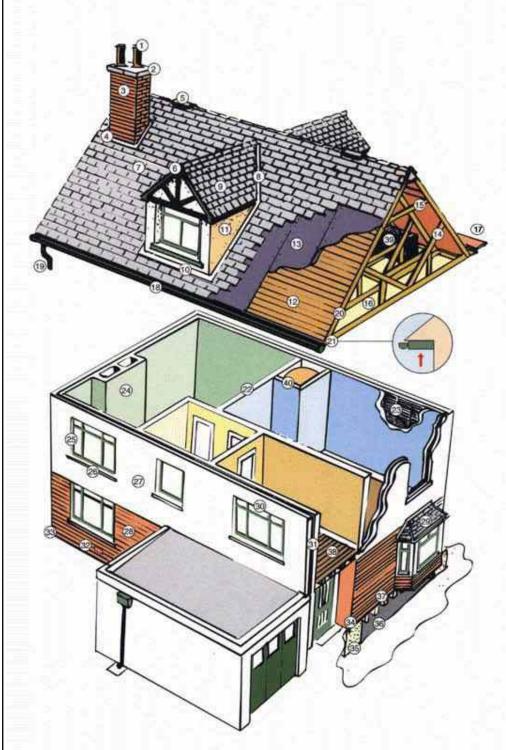
Sectional Diagram showing elements of a typical house

Reference may be made in this report to some or all of the above component parts of the property. This diagram may assist you in locating and understanding these items.

- 1) Chimney pots
- 2) Coping stone
- (3) Chimney head
- (4) Flashing
- 5) Ridge ventilation
- 6 Ridge board
- 7 Slates / tiles
- 8 Valley guttering
- 9 Dormer projection
- 10) Dormer flashing
- 11) Dormer cheeks
- (12) Sarking
- (13) Roof felt
- 14) Trusses
- (15) Collar
- 16) Insulation
- (17) Parapet gutter
- (18) Eaves guttering
- 19 Rainwater downpipe
- 20) Verge boards/skews
- 21) Soffit boards
- 22) Partition wall
- (23) Lath / plaster
- 24) Chimney breast
- 25) Window pointing
- 26) Window sills
- 27) Rendering
- (28) Brickwork / pointing
- 29 Bay window projection
- (30) Lintels
- (31) Cavity walls / wall ties
- 32) Subfloor ventilator
- (33) Damp proof course
- 34) Base course
- 35) Foundations
- 36) Solum
- 37) Floor joists
- 38) Floorboards
- 39) Water tank
- 40) Hot water tank
