# Home Report

# Single Survey

| Property address | 5 Robertson Drive<br>Bellshill<br>ML4 2EQ |
| Prepared by | Shepherd Chartered Surveyors |

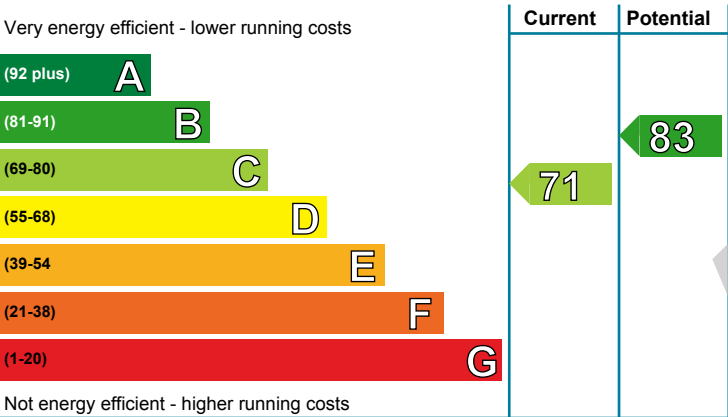
### Energy Efficiency Rating

This graph shows the current efficiency of your home, taking into account both energy efficiency and fuel costs. The higher this rating, the lower your fuel bills are likely to be.

Your current rating is **band C (71)**. The average rating for EPCs in Scotland is **band D (61)**.

The potential rating shows the effect of undertaking all of the improvement measures listed within your recommendations report.

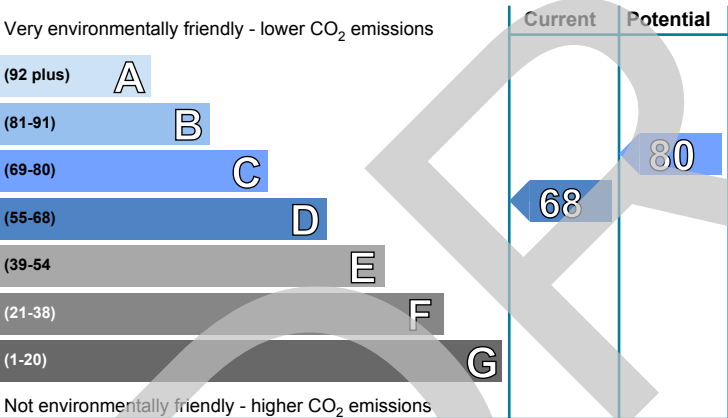
### Environmental Impact (CO<sub>2</sub>) Rating

This graph shows the effect of your home on the environment in terms of carbon dioxide (CO<sub>2</sub>) emissions. The higher the rating, the less impact it has on the environment.
