# HOME REPORT

# Energy Performance Certificate (EPC)

FLAT 26 , 1 ELDER STREET, NEW TOWN, EDINBURGH, EH1 3BS

# Single Survey

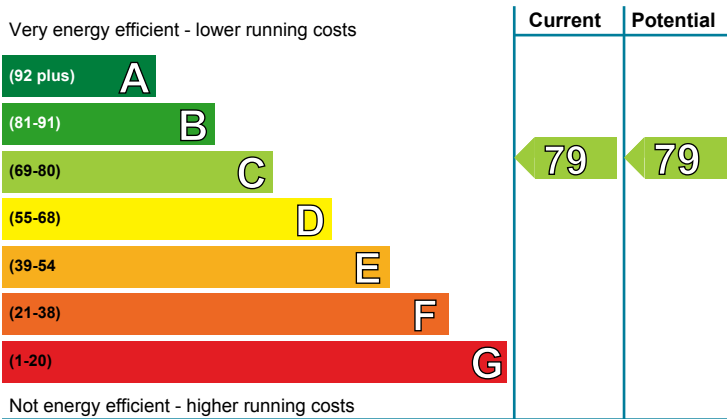
## Energy Efficiency Rating

This graph shows the current efficiency of your home, taking into account both energy efficiency and fuel costs. The higher this rating, the lower your fuel bills are likely to be.

Your current rating is **band C (79)**. The average rating for EPCs in Scotland is **band D (61)**.

The potential rating shows the effect of undertaking all of the improvement measures listed within your recommendations report.

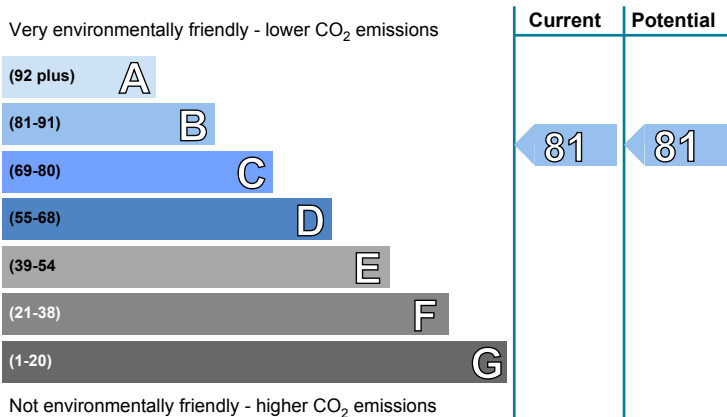
## Environmental Impact (CO<sub>2</sub>) Rating

This graph shows the effect of your home on the environment in terms of carbon dioxide (CO<sub>2</sub>) emissions. The higher the rating, the less impact it has on the environment.

The potential rating shows the effect of undertaking all of the improvement measures listed within your recommendations report.
