Home Report

4 GAMEKEEPER'S LOAN, CRAMOND, EDINBURGH, EH4 6LT

Scottish Single Survey

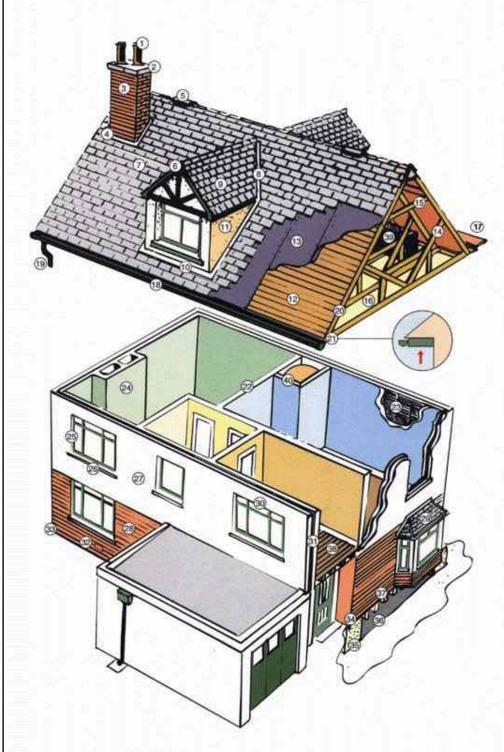
Sectional Diagram showing elements of a typical house

Reference may be made in this report to some or all of the above component parts of the property. This diagram may assist you in locating and understanding these items.

- 1 Chimney pots
- 2 Coping stone
- 3) Chimney head
- 4) Flashing
- (5) Ridge ventilation
- 6) Ridge board
- 7) Slates / tiles
- 8 Valley guttering
- 9) Dormer projection
- 10 Dormer flashing
- (11) Dormer cheeks
- (12) Sarking
- 13) Roof felt
- (14) Trusses
- 15) Collar
- (16) Insulation
- 17) Parapet gutter
- 18) Eaves guttering
- 19) Rainwater downpipe
- 0) Verge boards /skews
- 21) Soffit boards
- 22) Partition wall
- 23) Lath / plaster
- ×
- (24) Chimney breast
- 25) Window pointing
- 26 Window sills
- (27) Rendering
- (28) Brickwork / pointing
- 29) Bay window projection
- (30) Lintels
- (31) Cavity walls / wall ties
- 32) Subfloor ventilator
- 33) Damp proof course
- 34) Base course
- 35) Foundations
- 36) Solum
- 37) Floor joists
- 8 Floorboards
- 9) Water tank
- (40) Hot water tank
