# YOUR ONESURVEY HOME REPORT

7 Kirnie Gardens Dundee DD2 2FA

# SINGLE Survey

A report on the condition of the property, with categories being rated from 1 to 3.

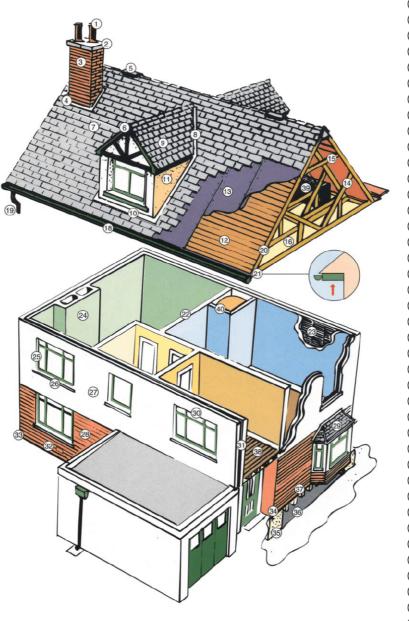
#### Sectional Diagram showing elements of a typical house

Reference may be made in this report to some or all of the above component parts of the property. This diagram may assist you in locating and understanding these items.
