SINGLE SURVEY

Surveyor Reference	EA1637
Customer	George Douglas
Selling address	North Cottage Ashbank Monifieth, Dundee DD5 4HX
Date of Inspection	31/05/2024
Prepared by	Gary Black, MRICS Dundee - Allied Surveyors Scotland Ltd

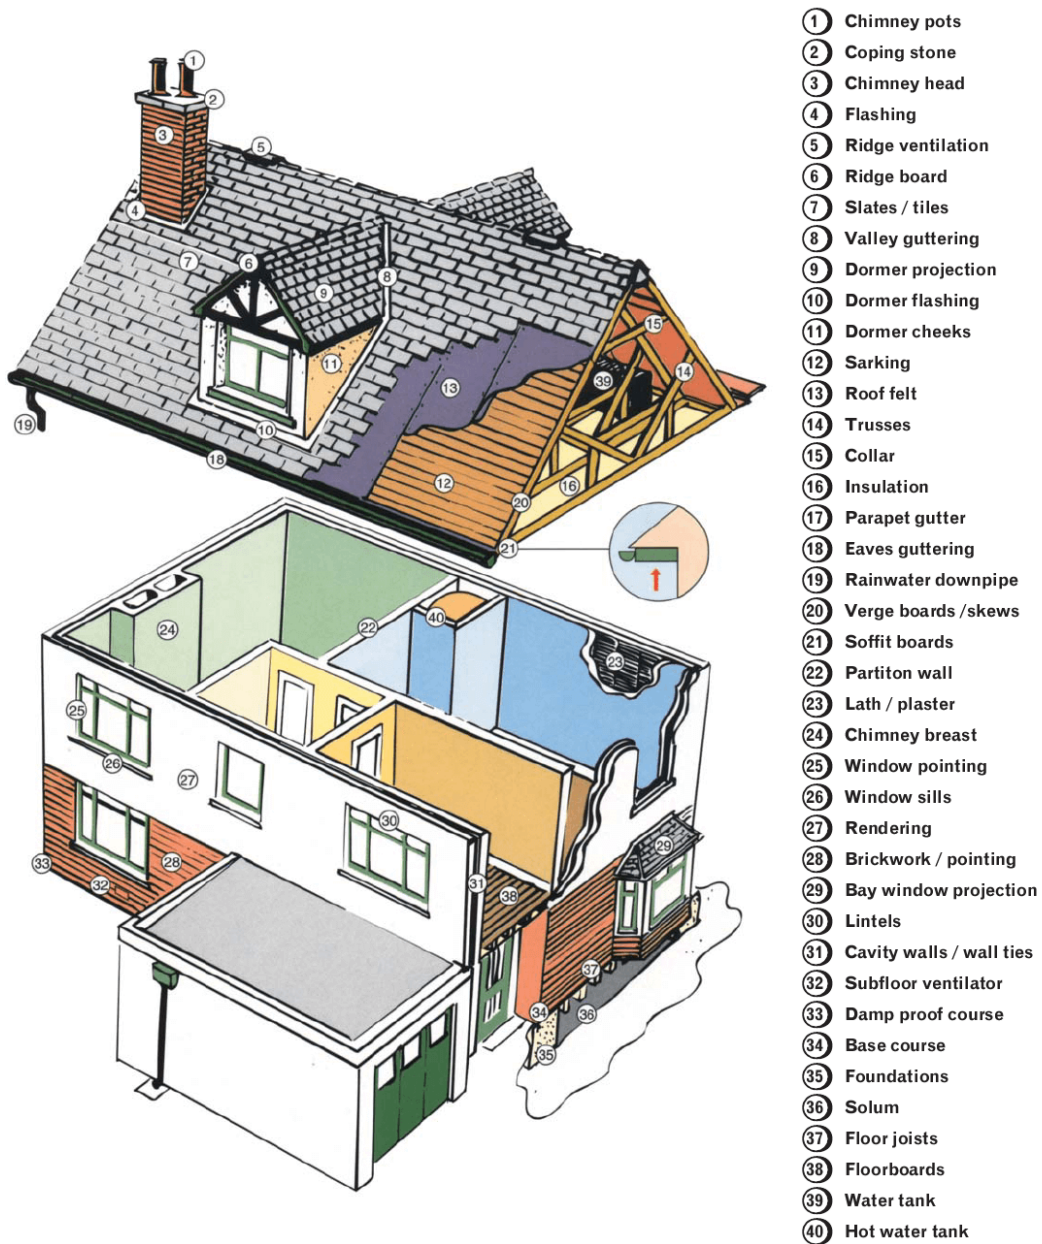
Sectional Diagram showing elements of a typical house

Reference may be made in this report to some or all of the above component parts of the property. This diagram may assist you in locating and understanding these items.
