Scottish Single Survey

Property address	51 Provost Reids Road Montrose DD10 8DZ
------------------	---

Prepared by	Shepherd Chartered Surveyors
-------------	------------------------------

Date of inspection	18/06/2024

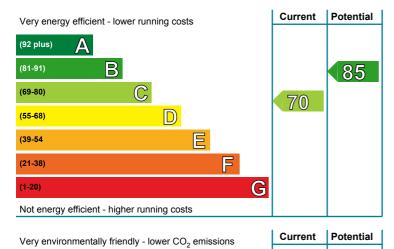
Energy Efficiency Rating

This graph shows the current efficiency of your home, taking into account both energy efficiency and fuel costs. The higher this rating, the lower your fuel bills are likely to be.
