# Home Report

274 Strathmartine Road  
Dundee DD3 8PN

## survey report on:

<b>Property address</b>	274 Strathmartine Road Dundee DD3 8PN
<b>Customer</b>	Mr John Johnstone
<b>Prepared by</b>	Graham + Sibbald LLP

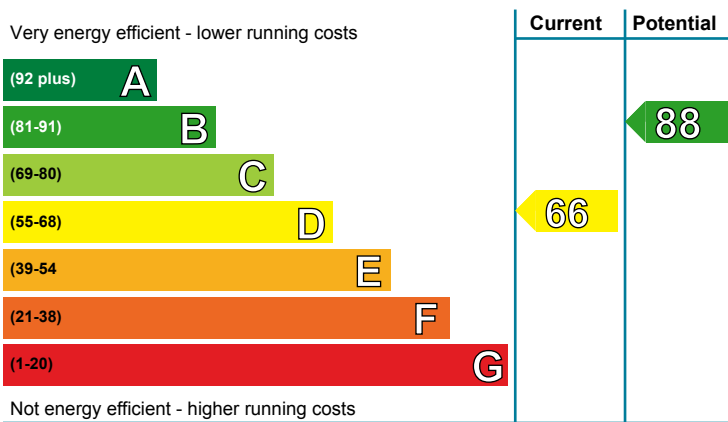
## Energy Efficiency Rating

This graph shows the current efficiency of your home, taking into account both energy efficiency and fuel costs. The higher this rating, the lower your fuel bills are likely to be.

Your current rating is **band D (66)**. The average rating for EPCs in Scotland is **band D (61)**.

The potential rating shows the effect of undertaking all of the improvement measures listed within your recommendations report.

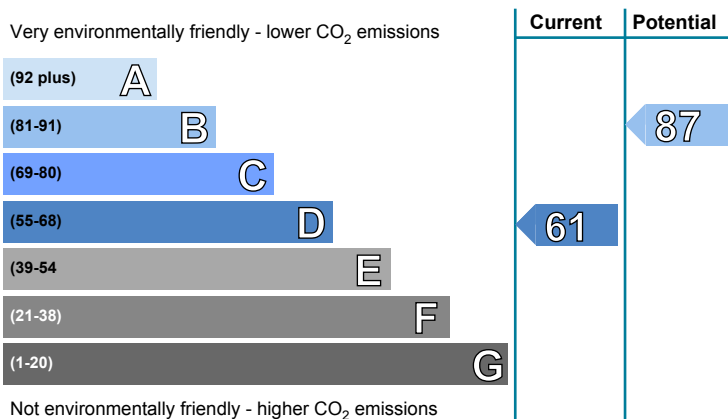
## Environmental Impact (CO<sub>2</sub>) Rating

This graph shows the effect of your home on the environment in terms of carbon dioxide (CO<sub>2</sub>) emissions. The higher the rating, the less impact it has on the environment.
