YOUR ONESURVEY HOME REPORT

75 Dundee Road
Broughty Ferry, Dundee
DD5 1NA

SINGLE SURVEY

Single Survey

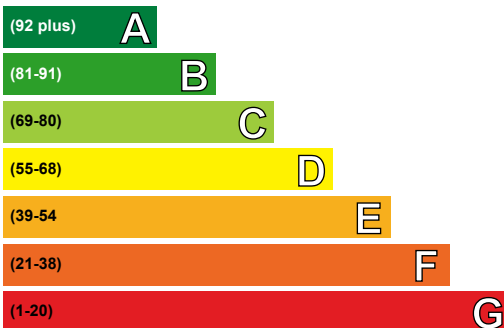
Very energy efficient - lower running costs

Not energy efficient - higher running costs

Current	Potential
64	79
