HOME
report

SINGLE SURVEY
ENERGY REPORT
PROPERTY QUESTIONNAIRE
VALUATION REPORT

Property address	42 Keirhill Way, Westhill, AB32 6AX
-------------------------	---

Prepared by	Harvey Donaldson & Gibson
--------------------	---------------------------

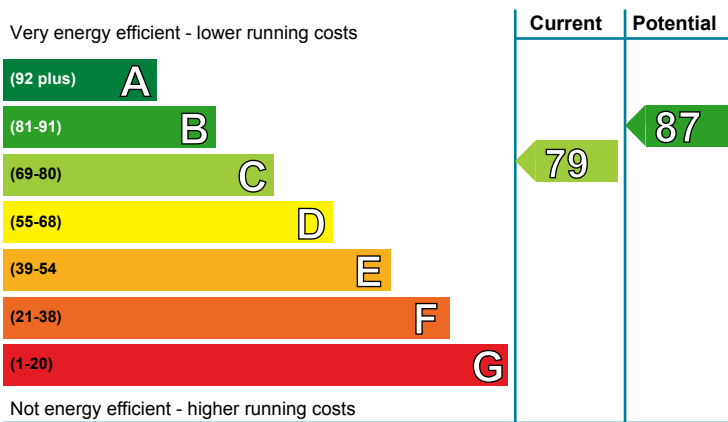
Energy Efficiency Rating

This graph shows the current efficiency of your home, taking into account both energy efficiency and fuel costs. The higher this rating, the lower your fuel bills are likely to be.

Your current rating is **band C (79)**. The average rating for EPCs in Scotland is **band D (61)**.

The potential rating shows the effect of undertaking all of the improvement measures listed within your recommendations report.
