Home Report

10 Harport Cottages Carbost Isle of Skye IV47 8SS

Single Survey

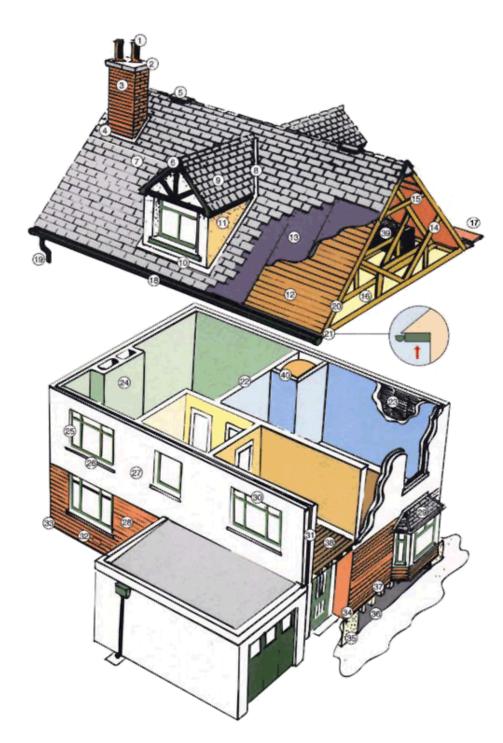
Sectional Diagram showing elements of a typical house

Reference may be made in this report to some or all of the above component parts of the property. This diagram may assist you in locating and understanding these items.

- 1) Chimney pots
- 2 Coping stone
- 3) Chimney head
- 4 Flashing
- 5) Ridge ventilation
- 6) Ridge board
- 7) Slates / tiles
- (8) Valley guttering
- 9 Dormer projection
- 10 Dormer flashing
- 11) Dormer cheeks
- (12) Sarking
- 13) Roof felt
- (14) Trusses
- (15) Collar
- 16) Insulation
- (17) Parapet gutter
- 18) Eaves guttering
- 19) Rainwater downpipe
- 20) Verge boards/skews
- Soffit boards
- 22) Partition wall
- 23) Lath / plaster
- 24) Chimney breast
- (25) Window pointing
 - 6) Window sills
- 27) Rendering
- (28) Brickwork / pointing
- 29) Bay window projection
- 30 Lintels
- (31) Cavity walls / wall ties
- 32) Subfloor ventilator
- 33 Damp proof course
- 34) Base course
- 35) Foundations
- 36) Solum
- 7) Floor joists
- 38) Floorboards
- 39) Water tank
- 40) Hot water tank
