Energy Performance Certificate (EPC)

NEXDEN, BACK ROAD, GOLSPIE, KW10 6RW

Single Survey

Property Address	Nexden Back Road Golspie KW10 6RW
Customer	Mr & Mrs C Mellish
Date of Inspection	28/08/2025
Prepared by	Jennifer Swanson Walker Fraser Steele

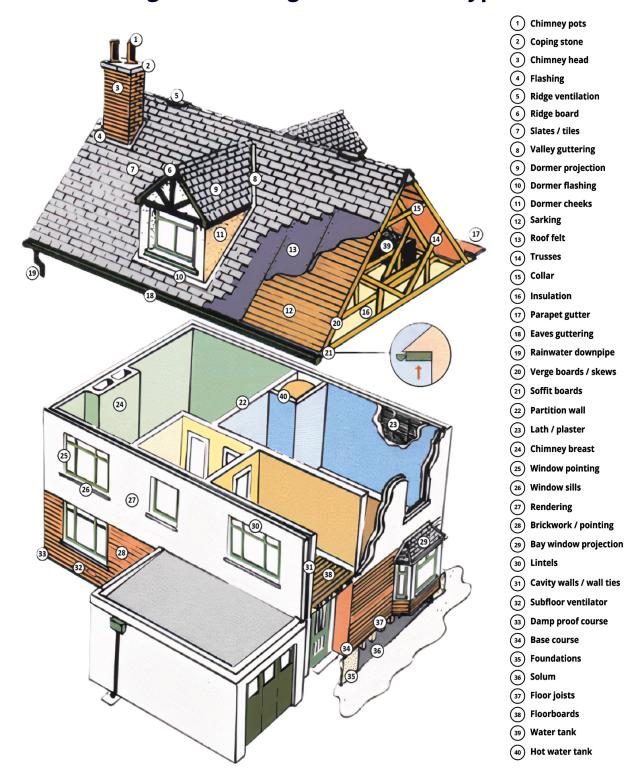
Sectional Diagram showing elements of a typical house

Reference may be made in this report to some or all of the above component parts of the property. This diagram may assist you in locating and understanding these items.
