Home Report

1 Crusader Avenue,
Glasgow,
G13 2JS

Single Survey

Property Address	1 Crusader Avenue, Glasgow, G13 2JS
Reference	1084753
Customer Name	Charles MacDonald
Date of Inspection	30th May 2025
Surveyor's name, qualifications and office	Paul Reilly BSc, MRICS DM Hall LLP Chartered Surveyors 3 Centura Court, Hillington Park Glasgow G52 4PR Tel: 0141 636 4141 email: glasgowresidential@dmhall.co.uk
Prepared By	DM Hall LLP

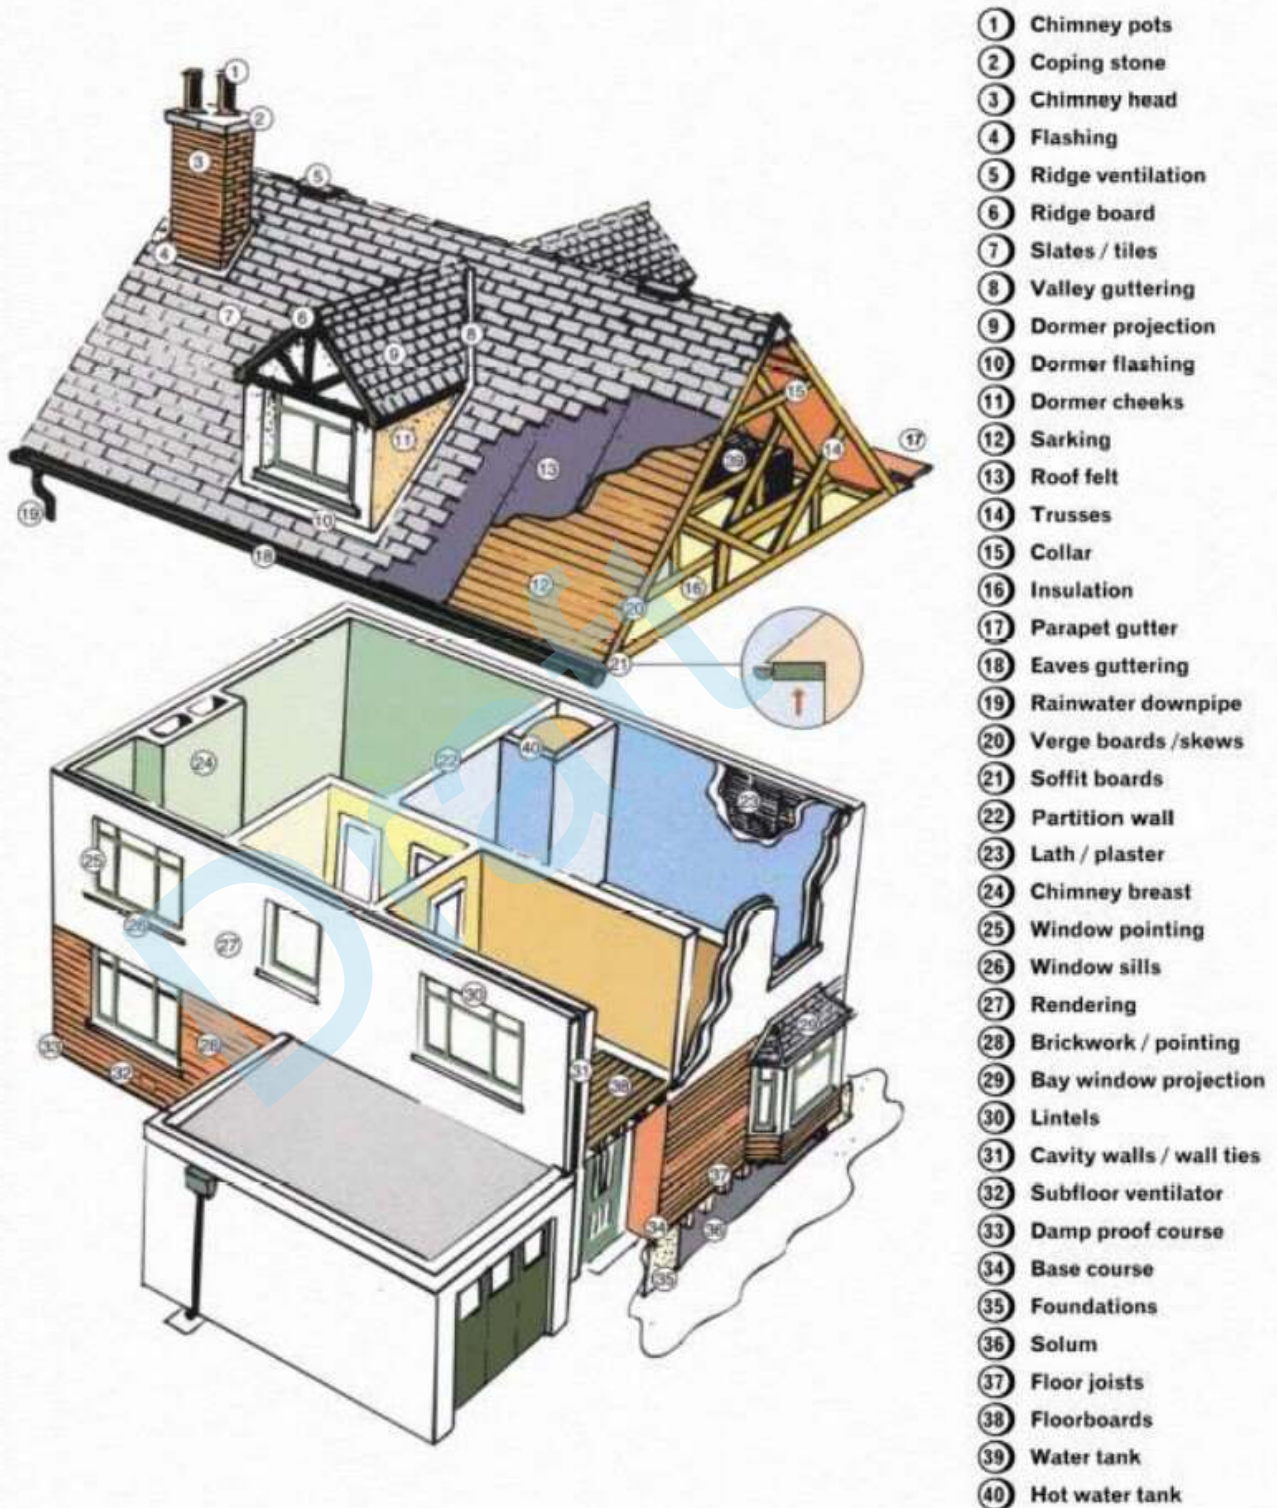
Sectional Diagram showing elements of a typical house

Reference may be made in this report to some or all of the above component parts of the property. This diagram may assist you in locating and understanding these items.
