Home Report

Beechbrook Kinneff Montrose DD10 0TA

Single Survey

Property Address	Beechbrook
' '	
	Montrose
	DD10 0TA
Customer	Mr Edwin Steel
Prepared by	Graham + Sibbald Property Consultants Limited
Date of Inspection	28/11/2025

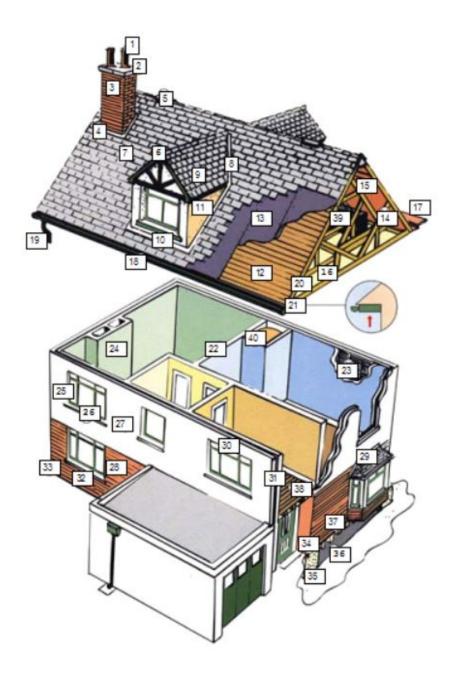
Sectional diagram showing elements of a typical house

1	Chimney pots
2	Coping stone
3	Chimney head
4	Flashing
5	Ridge ventilation
6	Ridge board
7	Slates / tiles
8	Valley guttering
9	Dormer projection
10	Dormer flashing
11	Dormer cheeks
12	Sarking
13	Roof felt
14	Trusses
15	Collar
16	Insulation
17	Parapet gutter
18	Eaves guttering
19	Rainwater downpipe
20	Verge boards / skews
21	Soffit boards
22	Partition wall
23	Lath / plaster
24	Chimney breast
25	Window pointing
26	Window sills
27	Rendering
28	Brickwork / pointing
29	Bay window projection
30	Lintels
31	Cavity walls / wall ties
32	Subfloor ventilator
33	Damp proof course
34	Base course
35	Foundations
36	Solum
37	Floor joists
38	Floorboards
39	Water tank
40	Hot water tank

Reference may be made in this report to some or all of the above component parts of the property. This diagram may assist you in locating and understanding these items.
