Home Report

Scottish Single Survey

Property address	49 Rugby Road Kilmarnock KA1 2DQ
------------------	--

Prepared by	Shepherd Chartered Surveyors
-------------	------------------------------

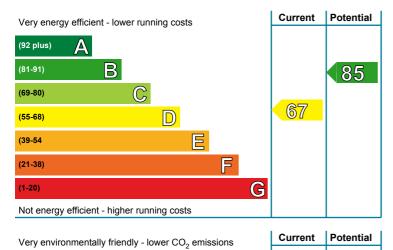
Energy Efficiency Rating

This graph shows the current efficiency of your home, taking into account both energy efficiency and fuel costs. The higher this rating, the lower your fuel bills are likely to be.
