Home Report

Scottish Single Survey

Property address	7 Drummilling Drive West Kilbride KA23 9BE
Customer	Mrs Dorothy Brackley
Customer address	7 Drummilling Drive West Kilbride KA23 9BE
Prepared by	Shepherd Chartered Surveyors
Date of inspection	25/06/2024

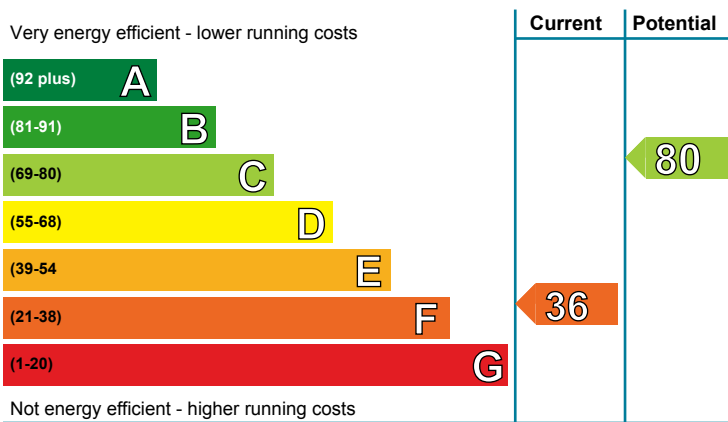
Energy Efficiency Rating

This graph shows the current efficiency of your home, taking into account both energy efficiency and fuel costs. The higher this rating, the lower your fuel bills are likely to be.

Your current rating is **band F (36)**. The average rating for EPCs in Scotland is **band D (61)**.

The potential rating shows the effect of undertaking all of the improvement measures listed within your recommendations report.

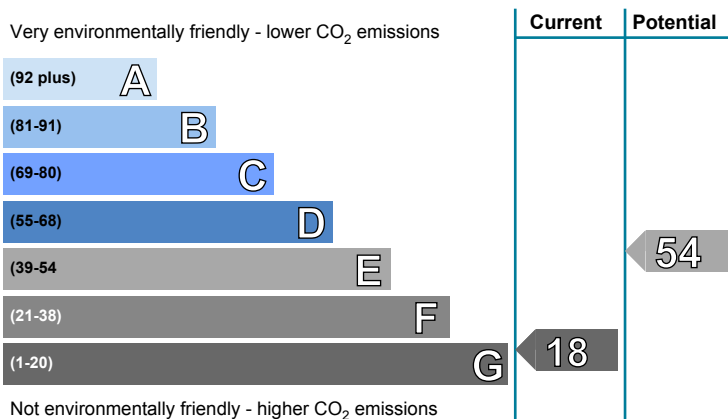
Environmental Impact (CO₂) Rating

This graph shows the effect of your home on the environment in terms of carbon dioxide (CO₂) emissions. The higher the rating, the less impact it has on the environment.
