Home Report

Single Survey

Property address	8 Treeswoodhead Road Kilmarnock KA1 4NB
-------------------------	---

Prepared by	Shepherd Chartered Surveyors
--------------------	------------------------------

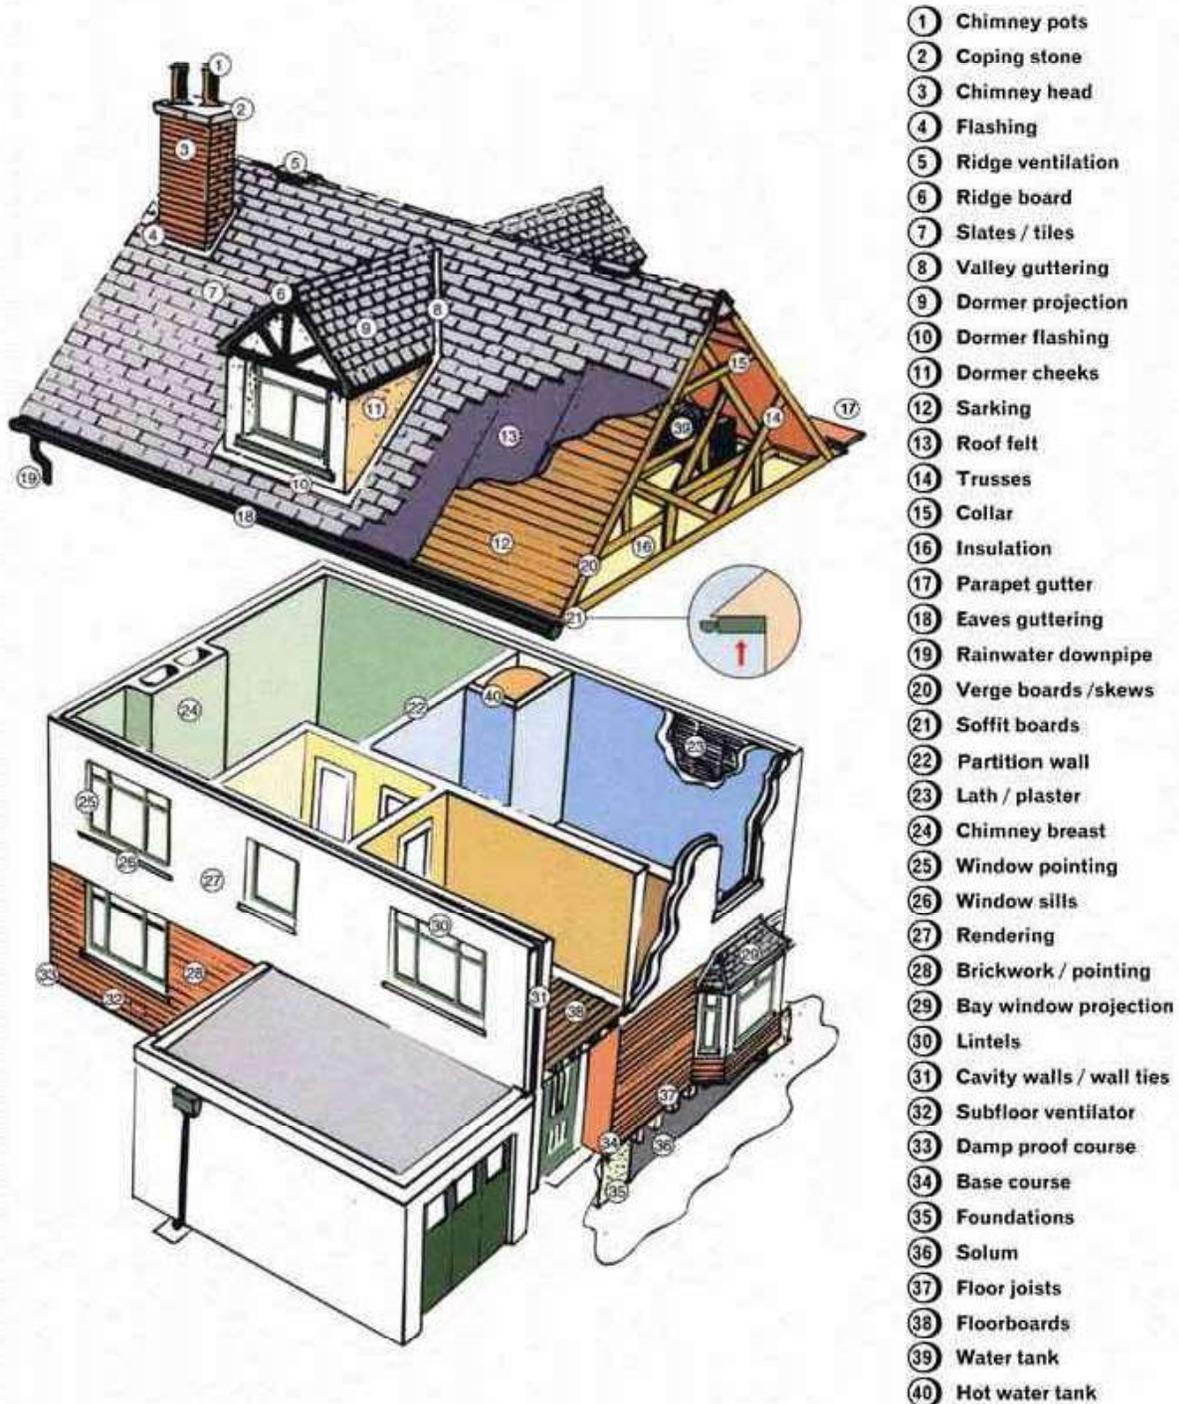
Sectional Diagram showing elements of a typical house

Reference may be made in this report to some or all of the above component parts of the property. This diagram may assist you in locating and understanding these items.

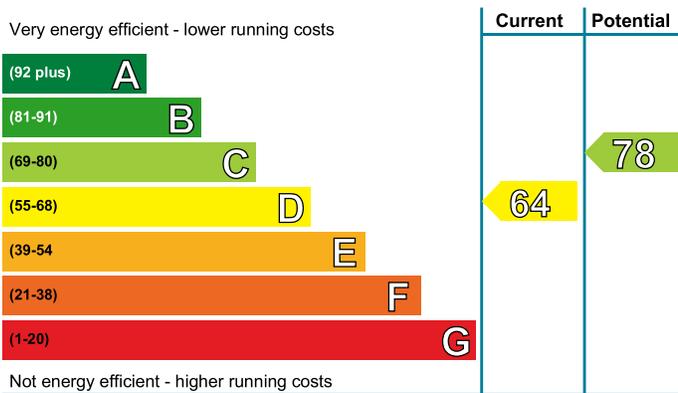
Energy Efficiency Rating

This graph shows the current efficiency of your home, taking into account both energy efficiency and fuel costs. The higher this rating, the lower your fuel bills are likely to be.

Your current rating is **band D (64)**. The average rating for EPCs in Scotland is **band D (61)**.

The potential rating shows the effect of undertaking all of the improvement measures listed within your recommendations report.

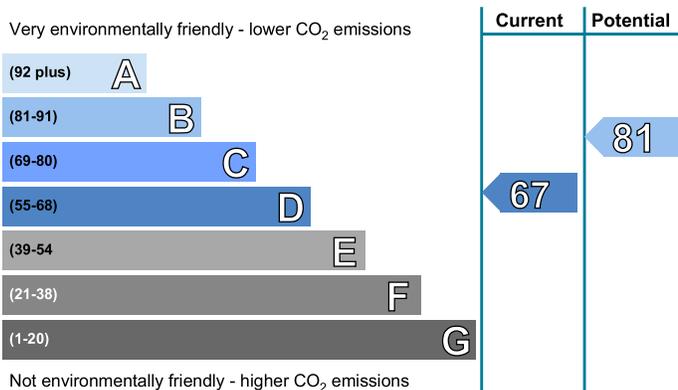
Environmental Impact (CO₂) Rating

This graph shows the effect of your home on the environment in terms of carbon dioxide (CO₂) emissions. The higher the rating, the less impact it has on the environment.
