HOME REPORT

310 TELFORD ROAD
EAST KILBRIDE
GLASGOW
G75 0DN

ENERGY REPORT

Energy Performance Certificate (EPC)

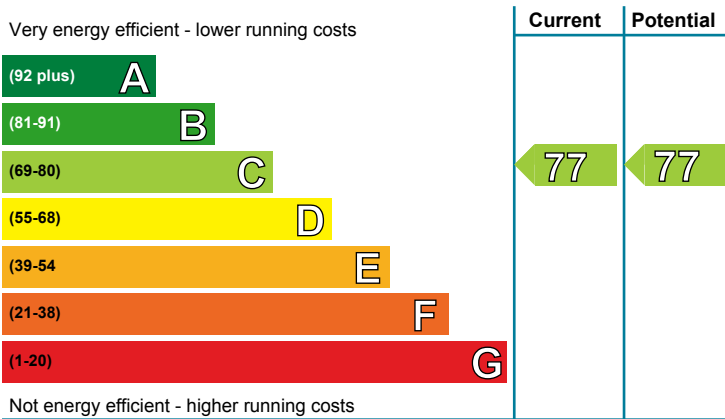
Energy Efficiency Rating

This graph shows the current efficiency of your home, taking into account both energy efficiency and fuel costs. The higher this rating, the lower your fuel bills are likely to be.

Your current rating is **band C (77)**. The average rating for EPCs in Scotland is **band D (61)**.

The potential rating shows the effect of undertaking all of the improvement measures listed within your recommendations report.
