HOME REPORT

64 ORWELL WYND
EAST KILBRIDE
GLASGOW
G75 8FZ

Energy Performance Certificate (EPC)

64 ORWELL WYND, EAST KILBRIDE, GLASGOW, G75 8FZ

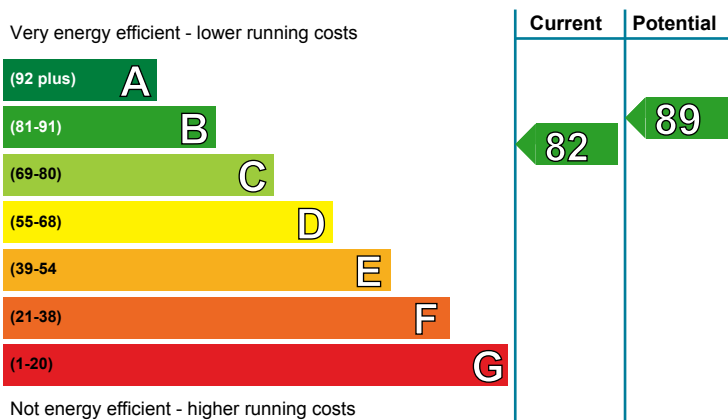
Energy Efficiency Rating

This graph shows the current efficiency of your home, taking into account both energy efficiency and fuel costs. The higher this rating, the lower your fuel bills are likely to be.

Your current rating is **band B (82)**. The average rating for EPCs in Scotland is **band D (61)**.

The potential rating shows the effect of undertaking all of the improvement measures listed within your recommendations report.
