HOME REPORT

16 BROCKLINN PARK
EAST KILBRIDE
GLASGOW
G75 8PW

Energy Performance Certificate (EPC)

Dwelling type: Mid-terrace house
Date of assessment: 31 May 2024
Date of certificate: 03 June 2024
Total floor area: 53 m²
Primary Energy Indicator: 357 kWh/m²/year

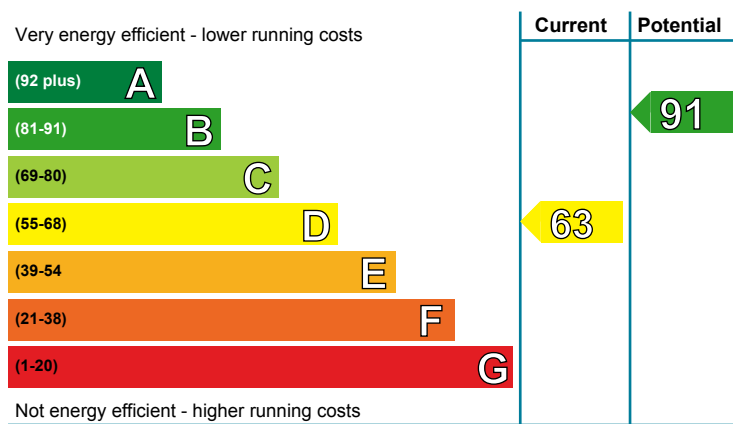
Energy Efficiency Rating

This graph shows the current efficiency of your home, taking into account both energy efficiency and fuel costs. The higher this rating, the lower your fuel bills are likely to be.

Your current rating is **band D (63)**. The average rating for EPCs in Scotland is **band D (61)**.

The potential rating shows the effect of undertaking all of the improvement measures listed within your recommendations report.

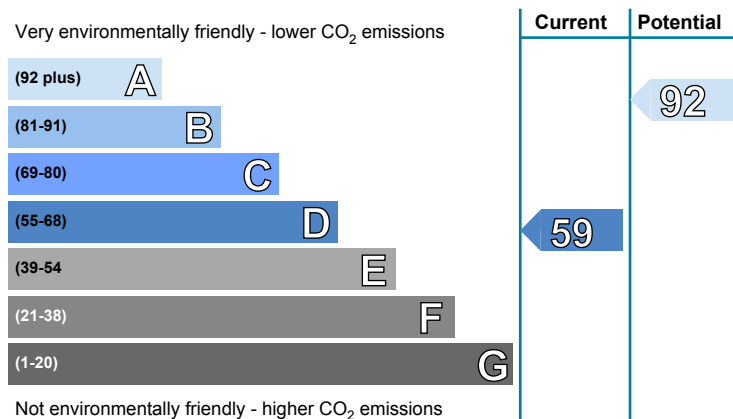
Environmental Impact (CO₂) Rating

This graph shows the effect of your home on the environment in terms of carbon dioxide (CO₂) emissions. The higher the rating, the less impact it has on the environment.

Your current rating is **band D (59)**. The average rating for EPCs in Scotland is **band D (59)**.

The potential rating shows the effect of undertaking all of the improvement measures listed within your recommendations report.

The average Scottish household produces about 6 tonnes of carbon dioxide every year. Based on this assessment, heating and lighting this home currently produces approximately 3.3 tonnes of carbon dioxide every year. Adopting recommendations in this report can reduce emissions and protect the environment. If you were to install all of these recommendations this could reduce emissions by 2.4 tonnes per year. You could reduce emissions even more by switching to renewable energy sources.
