HOME REPORT

40 SEMPHILL GARDENS
EAST KILBRIDE
GLASGOW
G74 3UH

Energy Performance Certificate (EPC)

40 SEMPHILL GARDENS, EAST KILBRIDE, GLASGOW, G74 3UH

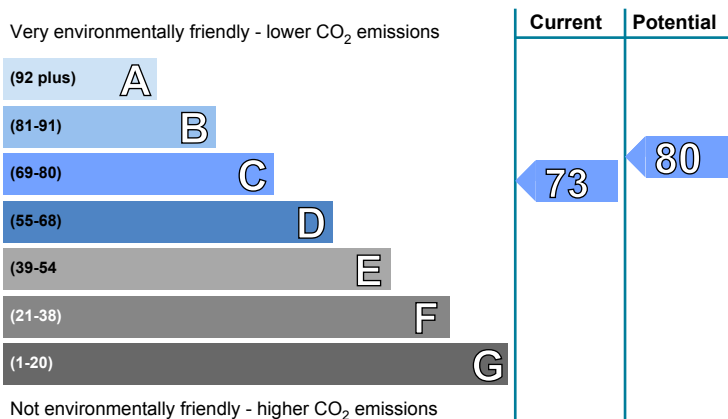
Environmental Impact (CO₂) Rating

This graph shows the effect of your home on the environment in terms of carbon dioxide (CO₂) emissions. The higher the rating, the less impact it has on the environment.

Your current rating is **band C (73)**. The average rating for EPCs in Scotland is **band D (59)**.

The potential rating shows the effect of undertaking all of the improvement measures listed within your recommendations report.
