Energy Performance Certificate (EPC)

72 WARWICK, EAST KILBRIDE, GLASGOW, G74 3PY

survey report on:

carvey report on:	
Property address	72 WARWICK, EAST KILBRIDE, GLASGOW, G74 3PY
Customer	Mr Gary Craig
Customer address	72 WARWICK, EAST KILBRIDE, GLASGOW, G74 3PY
Prepared by	Whyte & Barrie Chartered Surveyors
Date of inspection	10th September 2024

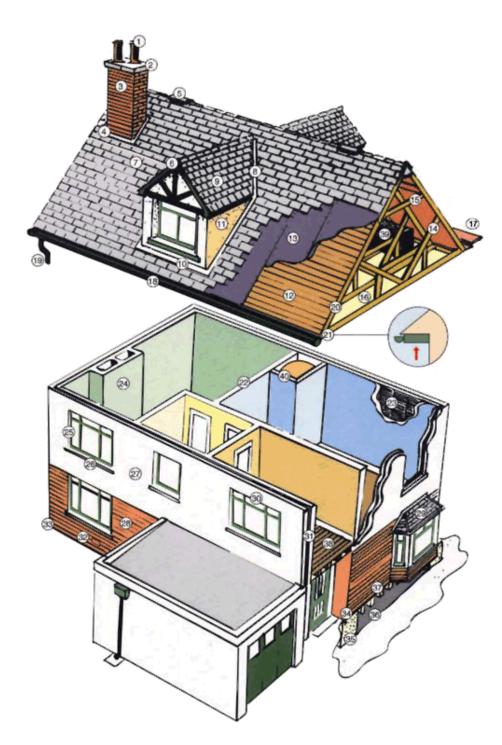
Sectional Diagram showing elements of a typical house

Reference may be made in this report to some or all of the above component parts of the property. This diagram may assist you in locating and understanding these items.

- 1) Chimney pots
- 2 Coping stone
- 3) Chimney head
- 4 Flashing
- 5 Ridge ventilation
- 6 Ridge board
- 7) Slates / tiles
- 8 Valley guttering
- 9 Dormer projection
- 10 Dormer flashing
- 11) Dormer cheeks
- 12) Sarking
- (13) Roof felt
- (14) Trusses
- (15) Collar
- (16) Insulation
- (17) Parapet gutter
- (18) Eaves guttering
- 19) Rainwater downpipe
- 20) Verge boards /skews
- 21) Soffit boards
- 22) Partition wall
- 23) Lath / plaster
- 24) Chimney breast
- (25) Window pointing
 - 6) Window sills
- 27) Rendering
- (28) Brickwork / pointing
- 29) Bay window projection
- 30 Lintels
- (31) Cavity walls / wall ties
- 32) Subfloor ventilator
- 33 Damp proof course
- 34) Base course
- 35) Foundations
- 36) Solum
- 37) Floor joists
- 38) Floorboards
- (39) Water tank
- 40 Hot water tank
