Energy Performance Certificate (EPC)

2 KELLIE GROVE, EAST KILBRIDE, GLASGOW, G74 4DN

Dwelling type: Detached bungalow
Date of assessment: 08 October 2024
Date of certificate: 08 October 2024

7 1	
Property address	2 KELLIE GROVE, EAST KILBRIDE, GLASGOW, G74 4DN
Customer	Ms. Lisa McNamara
	,
Customer address	2 KELLIE GROVE, EAST KILBRIDE, GLASGOW, G74 4DN
Prepared by	Whyte & Barrie Chartered Surveyors

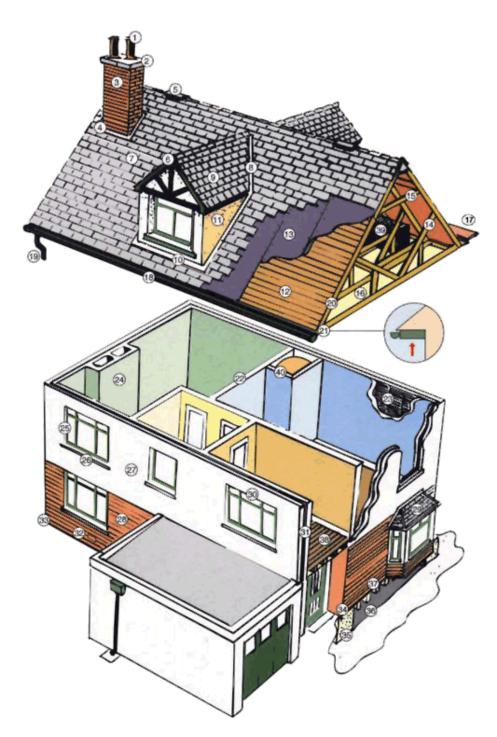
Sectional Diagram showing elements of a typical house

Reference may be made in this report to some or all of the above component parts of the property. This diagram may assist you in locating and understanding these items.

- 1) Chimney pots
- 2) Coping stone
- Chimney head
- 4 Flashing
- 5 Ridge ventilation
- 6 Ridge board
- 7) Slates / tiles
- 8 Valley guttering
- 9 Dormer projection
- 10 Dormer flashing
- 11) Dormer cheeks
- (12) Sarking
- (13) Roof felt
- (14) Trusses
- 15) Collar
- (16) Insulation
- 17) Parapet gutter
- (18) Eaves guttering
- 19) Rainwater downpipe
- 20) Verge boards /skews
- 21) Soffit boards
- 22) Partition wall
- 23) Lath / plaster
- (24) Chimney breast
- (25) Window pointing
 - 6) Window sills
- 27) Rendering
- (28) Brickwork / pointing
- 29) Bay window projection
- 30 Lintels
- (31) Cavity walls / wall ties
- 32) Subfloor ventilator
- 33 Damp proof course
- 34) Base course
- (35) Foundations
- 36) Solum
- 37) Floor joists
- 38) Floorboards
- 39) Water tank
- 40) Hot water tank
