Home Report

Scottish Single Survey

Property address	2 Murchison Drive East Kilbride Glasgow G75 8HF
Customer	Ms Susan Dickie Power of Attorney for mum
Customer address	2 Murchison Drive East Kilbride Glasgow G75 8HF
Prepared by	Shepherd Chartered Surveyors
Date of inspection	26/02/2025

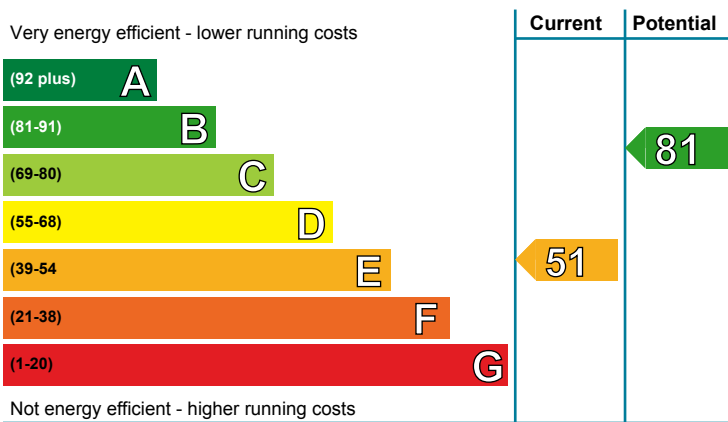
Energy Efficiency Rating

This graph shows the current efficiency of your home, taking into account both energy efficiency and fuel costs. The higher this rating, the lower your fuel bills are likely to be.

Your current rating is **band E (51)**. The average rating for EPCs in Scotland is **band D (61)**.

The potential rating shows the effect of undertaking all of the improvement measures listed within your recommendations report.

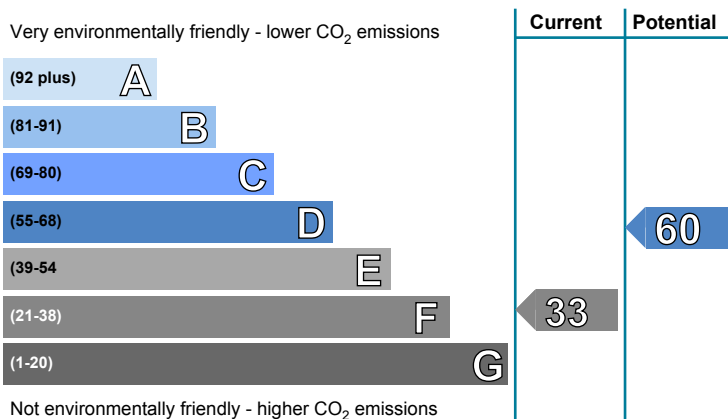
Environmental Impact (CO₂) Rating

This graph shows the effect of your home on the environment in terms of carbon dioxide (CO₂) emissions. The higher the rating, the less impact it has on the environment.
