## **Home Report**

Scottish
Single Survey

Property address	71 Sycamore Place East Kilbride Glasgow G75 9JU
Customer	Lynzi McCrorie
Customer address	71 Sycamore Place East Kilbride Glasgow G75 9JU
Prepared by	Shepherd Chartered Surveyors
Date of inspection	27/03/2025

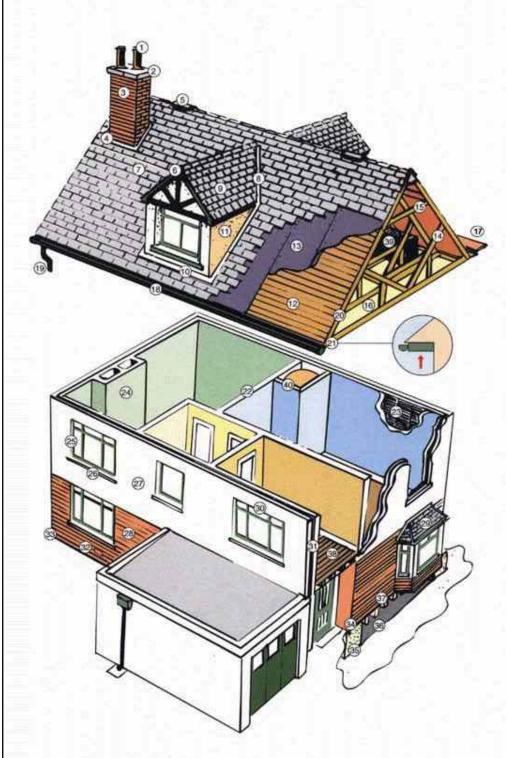
### Sectional Diagram showing elements of a typical house

Reference may be made in this report to some or all of the above component parts of the property. This diagram may assist you in locating and understanding these items.

- 1) Chimney pots
- 2) Coping stone
- 3 Chimney head
- (4) Flashing
- 5) Ridge ventilation
- 6 Ridge board
- 7 Slates / tiles
- 8 Valley guttering
- 9 Dormer projection
- 10 Dormer flashing
- 11) Dormer cheeks
- (12) Sarking
- (13) Roof felt
- (14) Trusses
- 15) Collar
- 16) Insulation
- (17) Parapet gutter
- 18) Eaves guttering
- (19) Rainwater downpipe
- 20) Verge boards /skews
- 21) Soffit boards
- 22) Partition wall
- 23) Lath / plaster
- (24) Chimney breast
- 25) Window pointing
- 26) Window sills
- 27) Rendering
- (28) Brickwork / pointing
- (29) Bay window projection
- (30) Lintels
- (31) Cavity walls / wall ties
- 32) Subfloor ventilator
- (33) Damp proof course
- 34) Base course
- 35) Foundations
- 36) Solum
- Floor joists
- 38) Floorboards
- 39) Water tank
- 40) Hot water tank
