Home Report

Single Survey

Property address	32 Glen Almond East Kilbride Glasgow G74 2JU
Customer	William MacDougall Executory
Customer address	32 Glen Almond East Kilbride Glasgow G74 2JU
Prepared by	Shepherd Chartered Surveyors
Date of inspection	28/02/2025

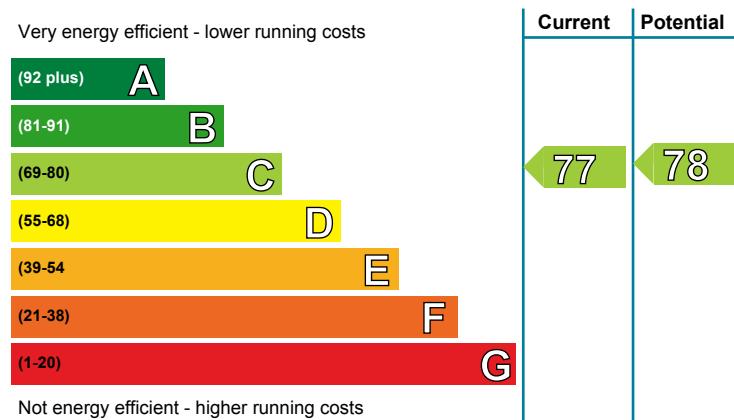
Energy Efficiency Rating

This graph shows the current efficiency of your home, taking into account both energy efficiency and fuel costs. The higher this rating, the lower your fuel bills are likely to be.

Your current rating is **band C (77)**. The average rating for EPCs in Scotland is **band D (61)**.

The potential rating shows the effect of undertaking all of the improvement measures listed within your recommendations report.

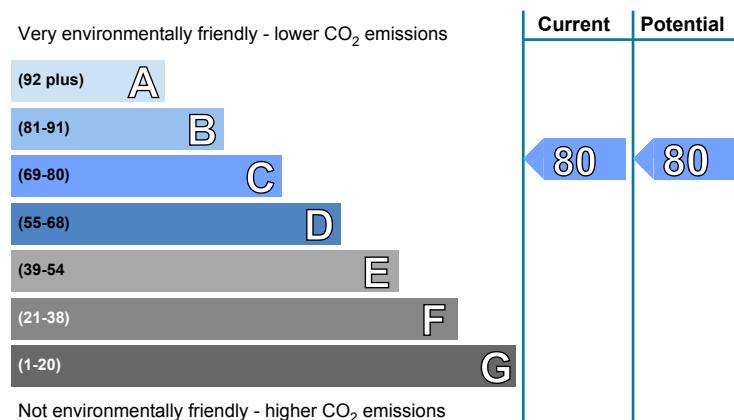
Environmental Impact (CO₂) Rating

This graph shows the effect of your home on the environment in terms of carbon dioxide (CO₂) emissions. The higher the rating, the less impact it has on the environment.
