Home Report

Scottish Single Survey

Single Survey

Property address	47 Alwyn Drive East Kilbride Glasgow G74 4RL
Customer	Jordan and Denise McCann
Customer address	47 Alwyn Drive East Kilbride Glasgow G74 4RL
Prepared by	Shepherd Chartered Surveyors
Date of inspection	14/01/2026

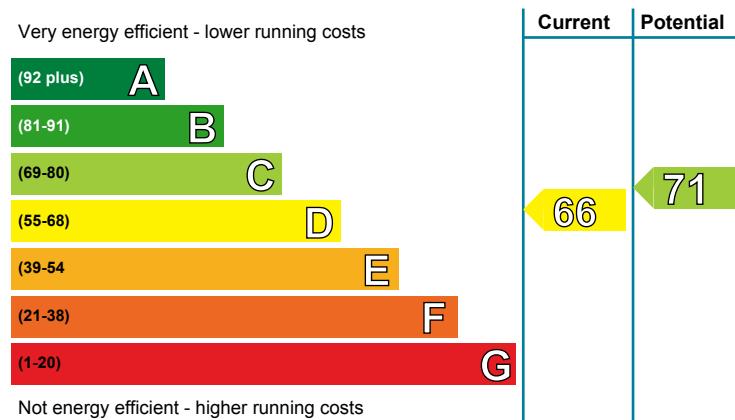
Energy Efficiency Rating

This graph shows the current efficiency of your home, taking into account both energy efficiency and fuel costs. The higher this rating, the lower your fuel bills are likely to be.

Your current rating is **band D (66)**. The average rating for EPCs in Scotland is **band D (61)**.

The potential rating shows the effect of undertaking all of the improvement measures listed within your recommendations report.

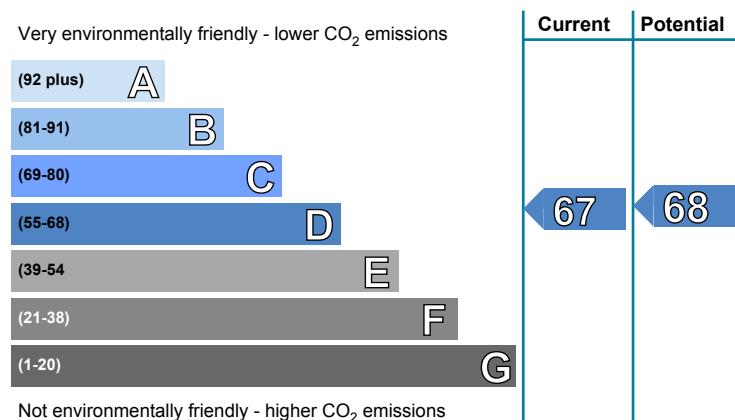
Environmental Impact (CO₂) Rating

This graph shows the effect of your home on the environment in terms of carbon dioxide (CO₂) emissions. The higher the rating, the less impact it has on the environment.
