Home Report

Single Survey

Property address	18 Tarbolton East Kilbride Glasgow G74 3SQ
Customer	Mr Yasir Aziz
Customer address	18 Tarbolton East Kilbride Glasgow G74 3SQ
Prepared by	Shepherd Chartered Surveyors
Date of inspection	22/01/2026

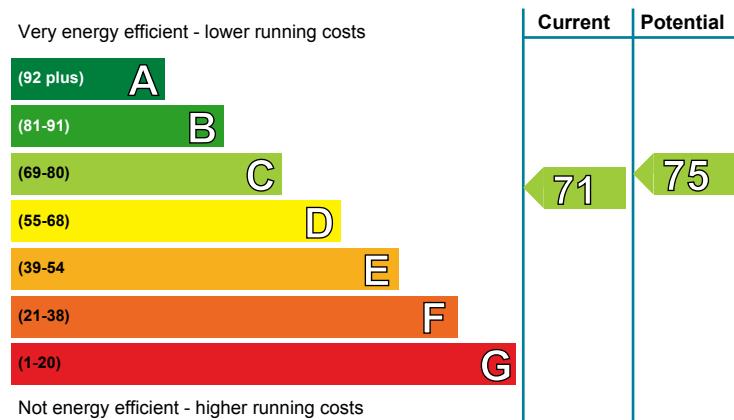
Energy Efficiency Rating

This graph shows the current efficiency of your home, taking into account both energy efficiency and fuel costs. The higher this rating, the lower your fuel bills are likely to be.

Your current rating is **band C (71)**. The average rating for EPCs in Scotland is **band D (61)**.

The potential rating shows the effect of undertaking all of the improvement measures listed within your recommendations report.

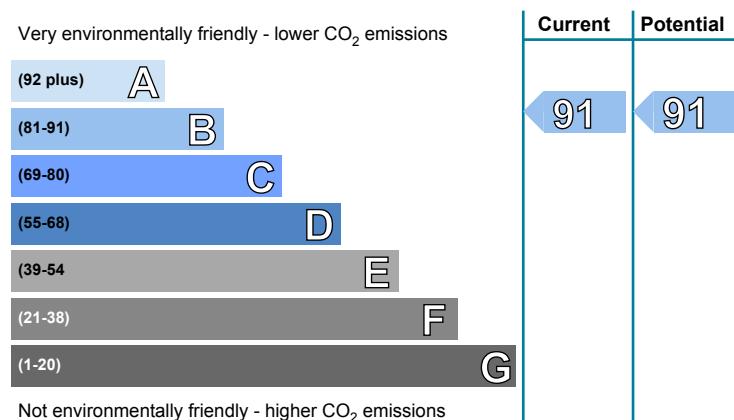
Environmental Impact (CO₂) Rating

This graph shows the effect of your home on the environment in terms of carbon dioxide (CO₂) emissions. The higher the rating, the less impact it has on the environment.
