YOUR ONESURVEY HOME REPORT

11 Craigbarnet Road Milngavie, Glasgow G62 7RA PREPARED FOR

SINGLE SURVEY

Surveyor Reference	ND/4977
Customer	Mr. Anil Randev
Selling address	11 Craigbarnet Road Milngavie, Glasgow
	G62 7RA
Date of Inspection	25/09/2024
Prepared by	Gavin J Smith, Bsc Hons MRICS
	Bearsden - Allied Surveyors Scotland Ltd

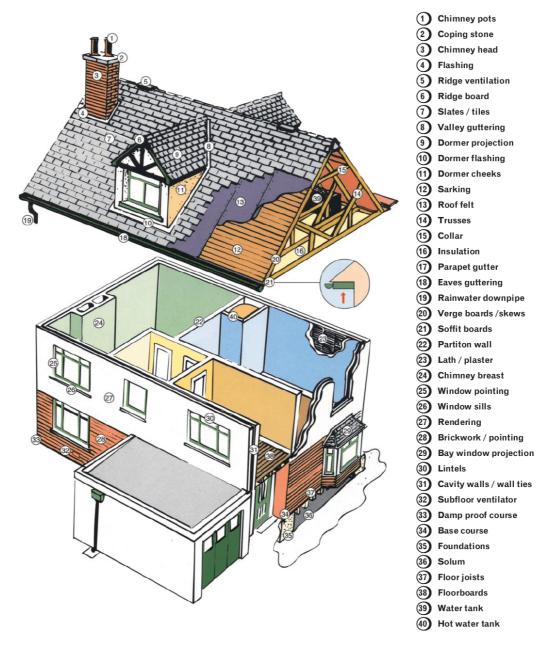
Sectional Diagram showing elements of a typical house

Reference may be made in this report to some or all of the above component parts of the property. This diagram may assist you in locating and understanding these items.
