HOME REPORT

Energy Performance Certificate (EPC)

19 BALKERACH STREET, DOUNE, FK16 6DE

SINGLE SURVEY

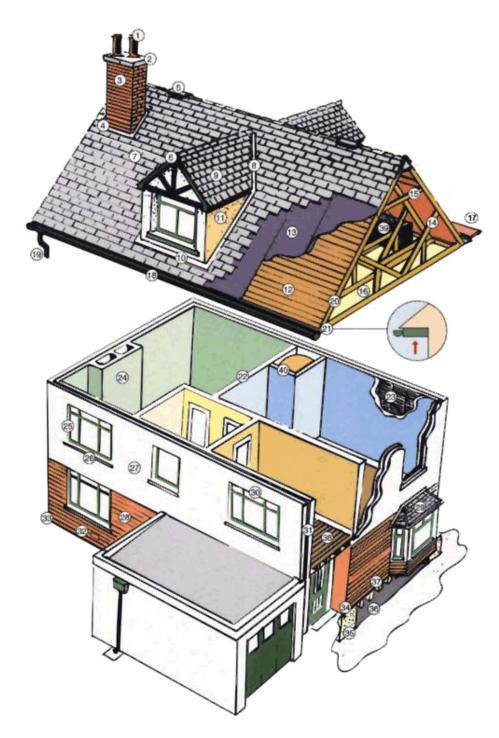
Sectional Diagram showing elements of a typical house

Reference may be made in this report to some or all of the above component parts of the property. This diagram may assist you in locating and understanding these items.

- 1) Chimney pots
- 2) Coping stone
- 3) Chimney head
- 4 Flashing
- 5) Ridge ventilation
- 6 Ridge board
- 7) Slates / tiles
- 8 Valley guttering
- 9 Dormer projection
- 10) Dormer flashing
- 11) Dormer cheeks
- 12) Sarking
- (13) Roof felt
- (14) Trusses
- (15) Collar
- 16 Insulation
- (17) Parapet gutter
- (18) Eaves guttering
- 19) Rainwater downpipe
- 20) Verge boards /skews
- 21) Soffit boards
- 22) Partition wall
- 23) Lath / plaster
- (24) Chimney breast
- 25) Window pointing
- Window sills
- 27) Rendering
- (28) Brickwork / pointing
- 29) Bay window projection
- 30 Lintels
- (31) Cavity walls / wall ties
- 32) Subfloor ventilator
- 33) Damp proof course
- 34) Base course
- 35) Foundations
- 36) Solum
- 37 Floor joists
- 8 Floorboards
- 39) Water tank
- 40 Hot water tank
