Home Report

Scottish Single Survey

Property address	15 Gladstone Place Stirling FK8 2NN
Customer	Mr Neil Malcolm & Alan J Skilling
Customer address	
Prepared by	Shepherd Chartered Surveyors
Date of inspection	28/09/2023

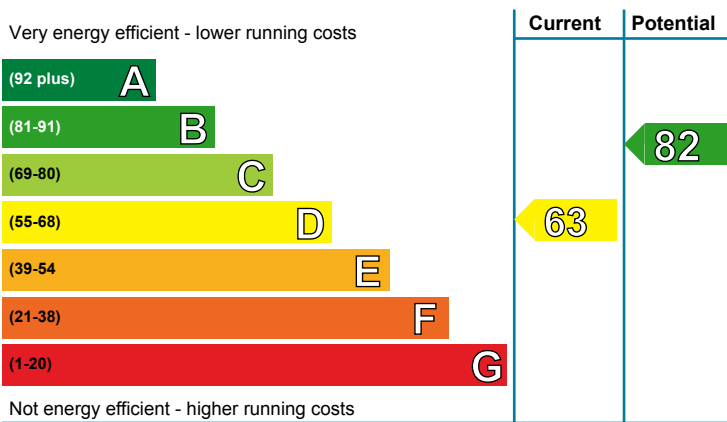
Energy Efficiency Rating

This graph shows the current efficiency of your home, taking into account both energy efficiency and fuel costs. The higher this rating, the lower your fuel bills are likely to be.

Your current rating is **band D (63)**. The average rating for EPCs in Scotland is **band D (61)**.

The potential rating shows the effect of undertaking all of the improvement measures listed within your recommendations report.

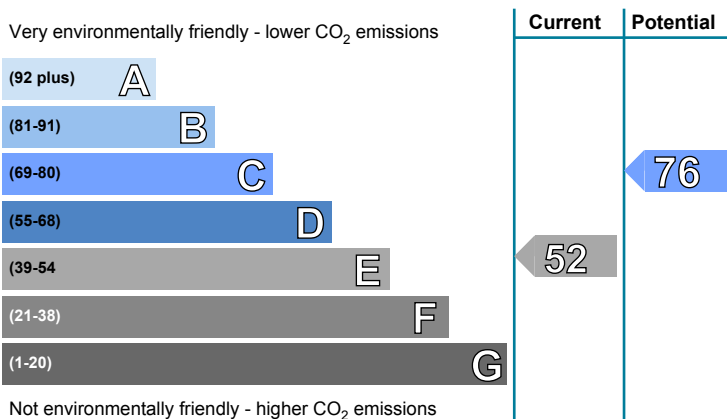
Environmental Impact (CO₂) Rating

This graph shows the effect of your home on the environment in terms of carbon dioxide (CO₂) emissions. The higher the rating, the less impact it has on the environment.
