HOME REPORT

19 HUNTERS WAY
HOLMHEAD
CUMNOCK
KA18 1AL

Energy Performance Certificate (EPC)

Single Survey

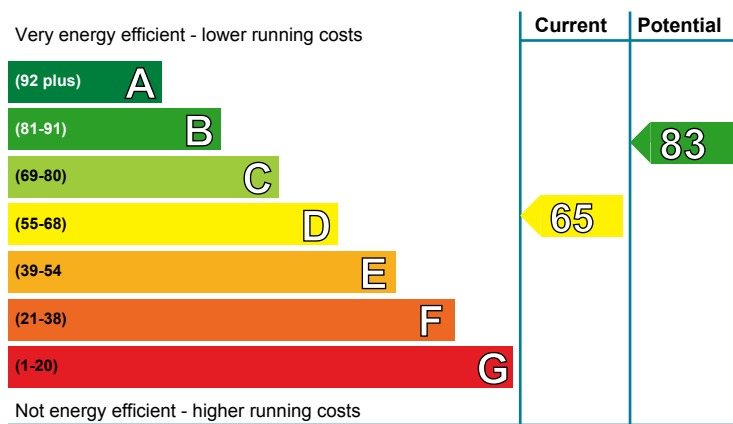
Energy Efficiency Rating

This graph shows the current efficiency of your home, taking into account both energy efficiency and fuel costs. The higher this rating, the lower your fuel bills are likely to be.

Your current rating is **band D (65)**. The average rating for EPCs in Scotland is **band D (61)**.

The potential rating shows the effect of undertaking all of the improvement measures listed within your recommendations report.

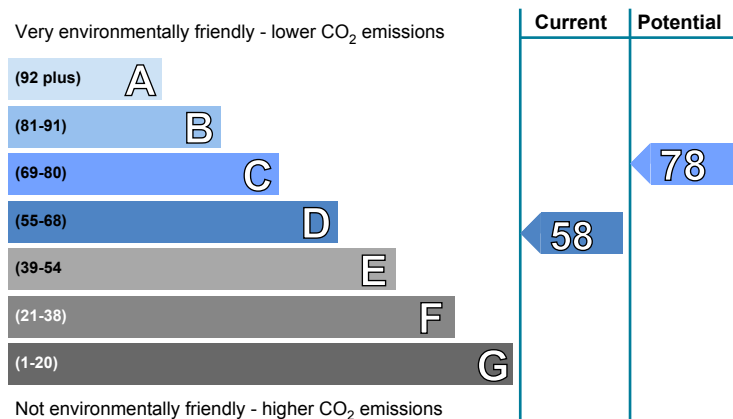
Environmental Impact (CO₂) Rating

This graph shows the effect of your home on the environment in terms of carbon dioxide (CO₂) emissions. The higher the rating, the less impact it has on the environment.

Your current rating is **band D (58)**. The average rating for EPCs in Scotland is **band D (59)**.

The potential rating shows the effect of undertaking all of the improvement measures listed within your recommendations report.
