# HOME REPORT

4 HARPERLAND  
DUNDONALD  
KILMARNOCK  
KA2 9BY

# Energy Performance Certificate (EPC)

4 HARPERLAND, DUNDONALD, KILMARNOCK, KA2 9BY

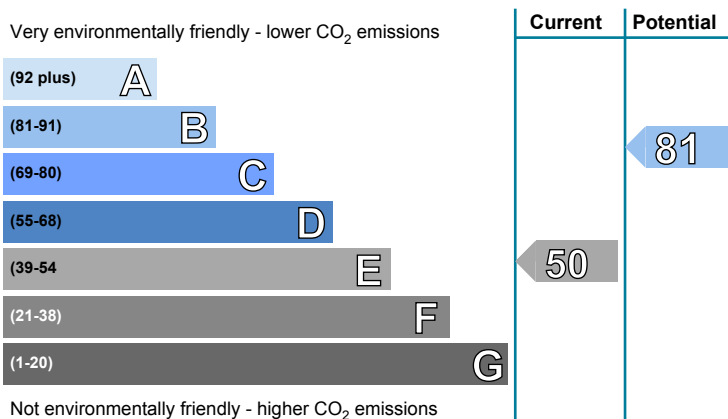
## Environmental Impact (CO<sub>2</sub>) Rating

This graph shows the effect of your home on the environment in terms of carbon dioxide (CO<sub>2</sub>) emissions. The higher the rating, the less impact it has on the environment.

Your current rating is **band E (50)**. The average rating for EPCs in Scotland is **band D (59)**.

The potential rating shows the effect of undertaking all of the improvement measures listed within your recommendations report.
