HOME REPORT

17 BRIDGEND
KILWINNING
KA13 7LY

Energy Performance Certificate (EPC)

Single Survey

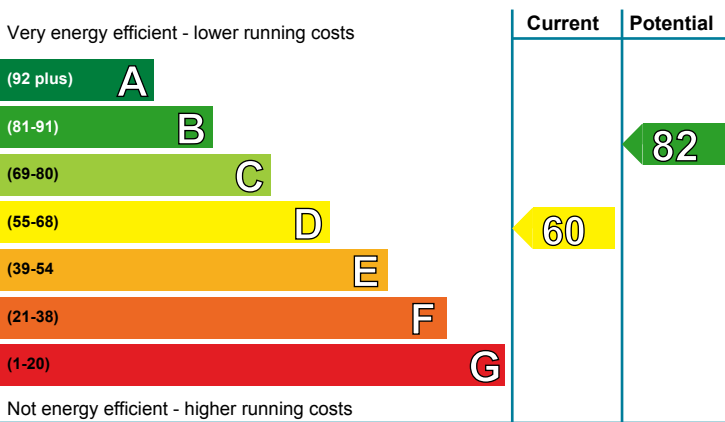
Energy Efficiency Rating

This graph shows the current efficiency of your home, taking into account both energy efficiency and fuel costs. The higher this rating, the lower your fuel bills are likely to be.

Your current rating is **band D (60)**. The average rating for EPCs in Scotland is **band D (61)**.

The potential rating shows the effect of undertaking all of the improvement measures listed within your recommendations report.

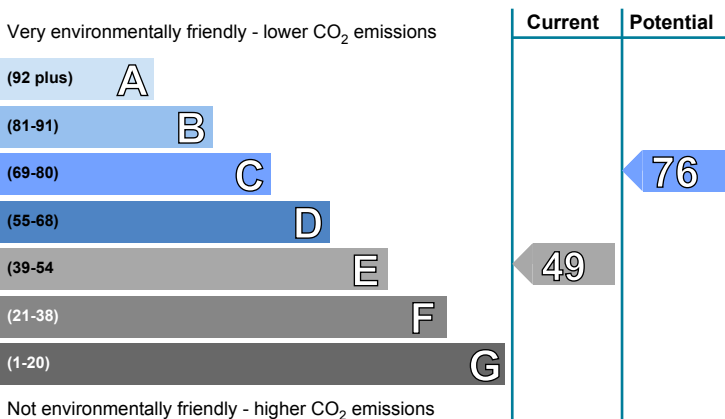
Environmental Impact (CO₂) Rating

This graph shows the effect of your home on the environment in terms of carbon dioxide (CO₂) emissions. The higher the rating, the less impact it has on the environment.

Your current rating is **band E (49)**. The average rating for EPCs in Scotland is **band D (59)**.

The potential rating shows the effect of undertaking all of the improvement measures listed within your recommendations report.
