HOME REPORT

BANK VIEW
57 ST LEONARDS ROAD
FORRES
IV36 1DW

Energy Performance Certificate (EPC)

BANK VIEW, 57 ST LEONARDS ROAD, FORRES, IV36 1DW

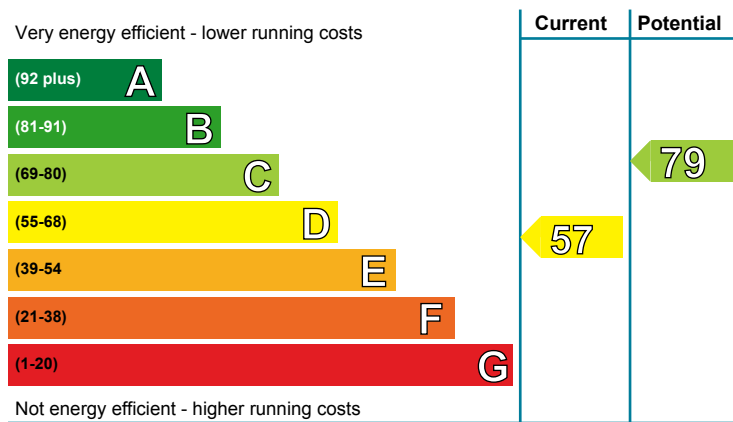
Energy Efficiency Rating

This graph shows the current efficiency of your home, taking into account both energy efficiency and fuel costs. The higher this rating, the lower your fuel bills are likely to be.

Your current rating is **band D (57)**. The average rating for EPCs in Scotland is **band D (61)**.

The potential rating shows the effect of undertaking all of the improvement measures listed within your recommendations report.

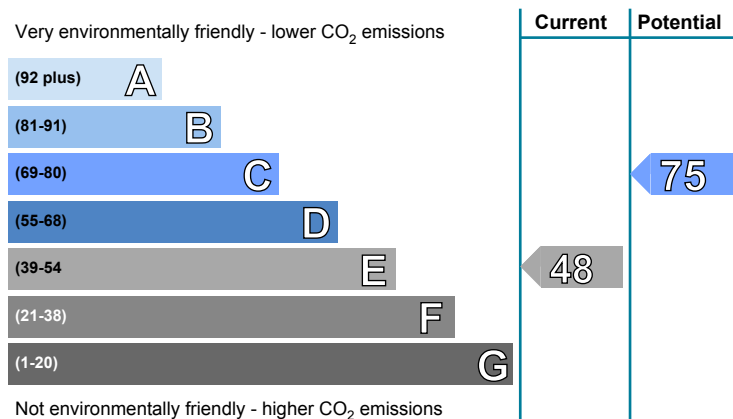
Environmental Impact (CO₂) Rating

This graph shows the effect of your home on the environment in terms of carbon dioxide (CO₂) emissions. The higher the rating, the less impact it has on the environment.

Your current rating is **band E (48)**. The average rating for EPCs in Scotland is **band D (59)**.

The potential rating shows the effect of undertaking all of the improvement measures listed within your recommendations report.

The average Scottish household produces about 6 tonnes of carbon dioxide every year. Based on this assessment, heating and lighting this home currently produces approximately 7.6 tonnes of carbon dioxide every year. Adopting recommendations in this report can reduce emissions and protect the environment. If you were to install all of these recommendations this could reduce emissions by 3.9 tonnes per year. You could reduce emissions even more by switching to renewable energy sources.
