HOME REPORT

West Steading Aldroughty

Elgin
IV30 8UN

Energy Performance Certificate (EPC)

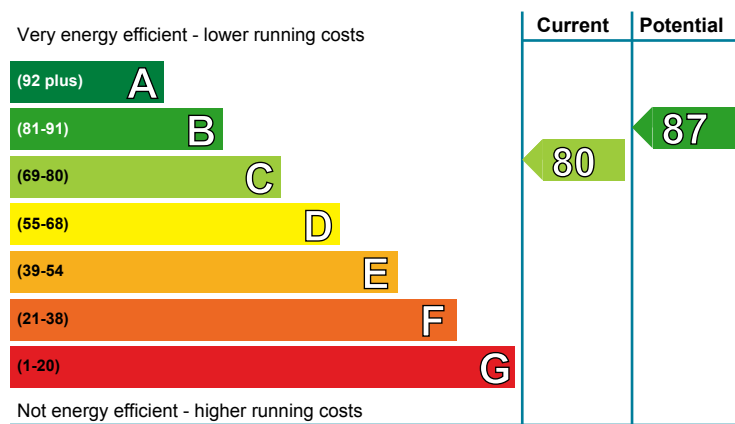
Energy Efficiency Rating

This graph shows the current efficiency of your home, taking into account both energy efficiency and fuel costs. The higher this rating, the lower your fuel bills are likely to be.

Your current rating is **band C (80)**. The average rating for EPCs in Scotland is **band D (61)**.

The potential rating shows the effect of undertaking all of the improvement measures listed within your recommendations report.

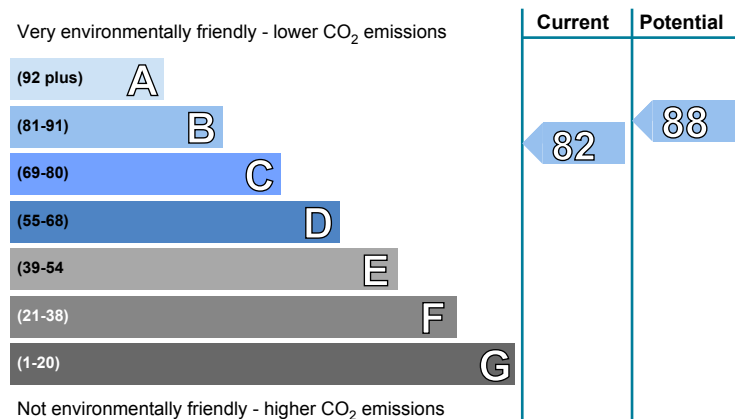
Environmental Impact (CO₂) Rating

This graph shows the effect of your home on the environment in terms of carbon dioxide (CO₂) emissions. The higher the rating, the less impact it has on the environment.

Your current rating is **band B (82)**. The average rating for EPCs in Scotland is **band D (59)**.

The potential rating shows the effect of undertaking all of the improvement measures listed within your recommendations report.
